Monitoring and Laboratory Division
Vapor Recovery and Fuel Transfer Branch
Vapor Recovery Regulatory Development Section

Project Number: VR-11-11

Overpressure Study

Technical Support Document
Nozzle Replacement Study at Gasoline Dispensing Facility
Equipped with Assist Phase II Enhanced Vapor Recovery System
Exhibiting Pressure Increase While Dispensing

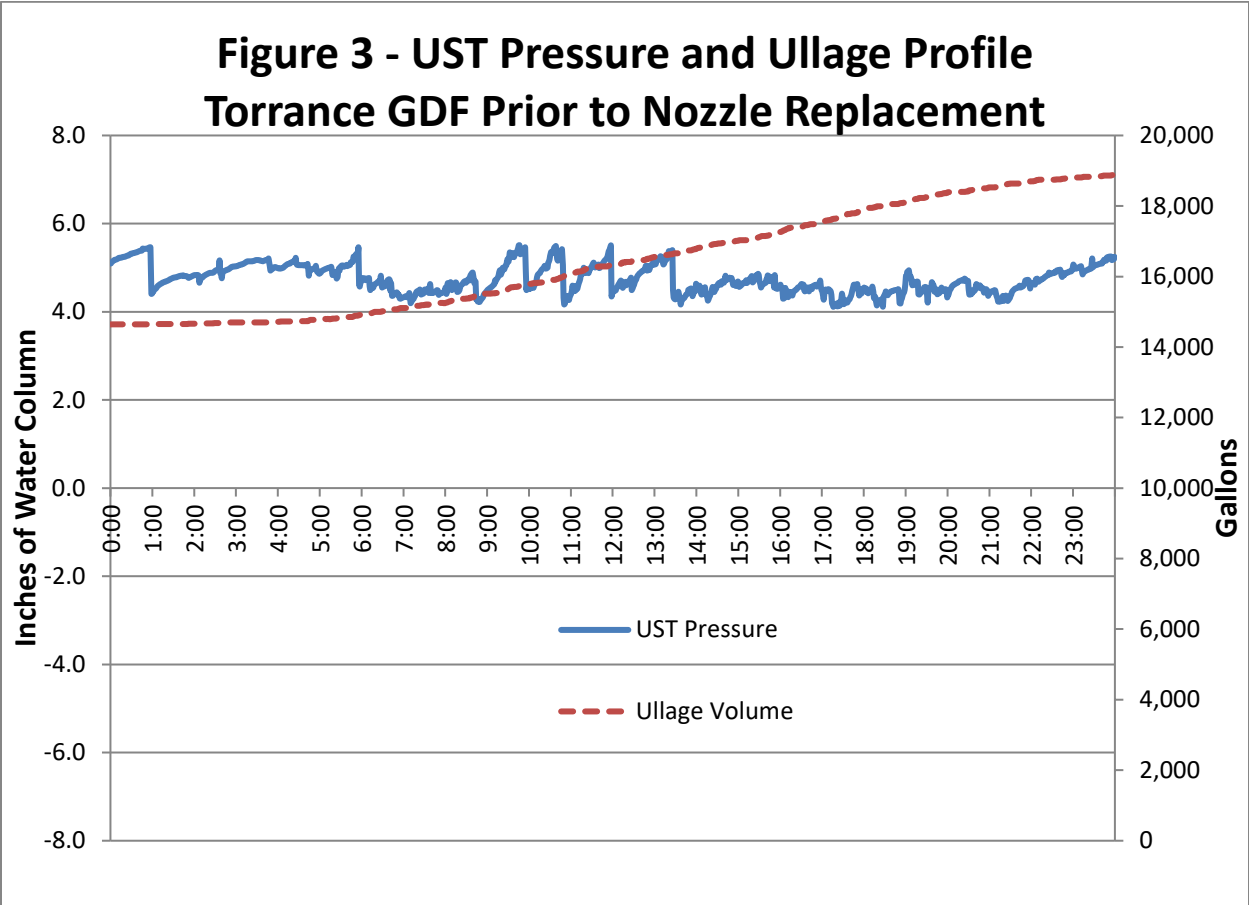
Date	Daily Min (inches water column)	Daily Max (inches water column)	Daily Average (inches water column)	PWD ?
11/5/2014	1.2	5.9	4.1	Yes
11/6/2014	1.6	5.6	3.7	Yes
11/7/2014	4.1	5.5	4.7	Yes

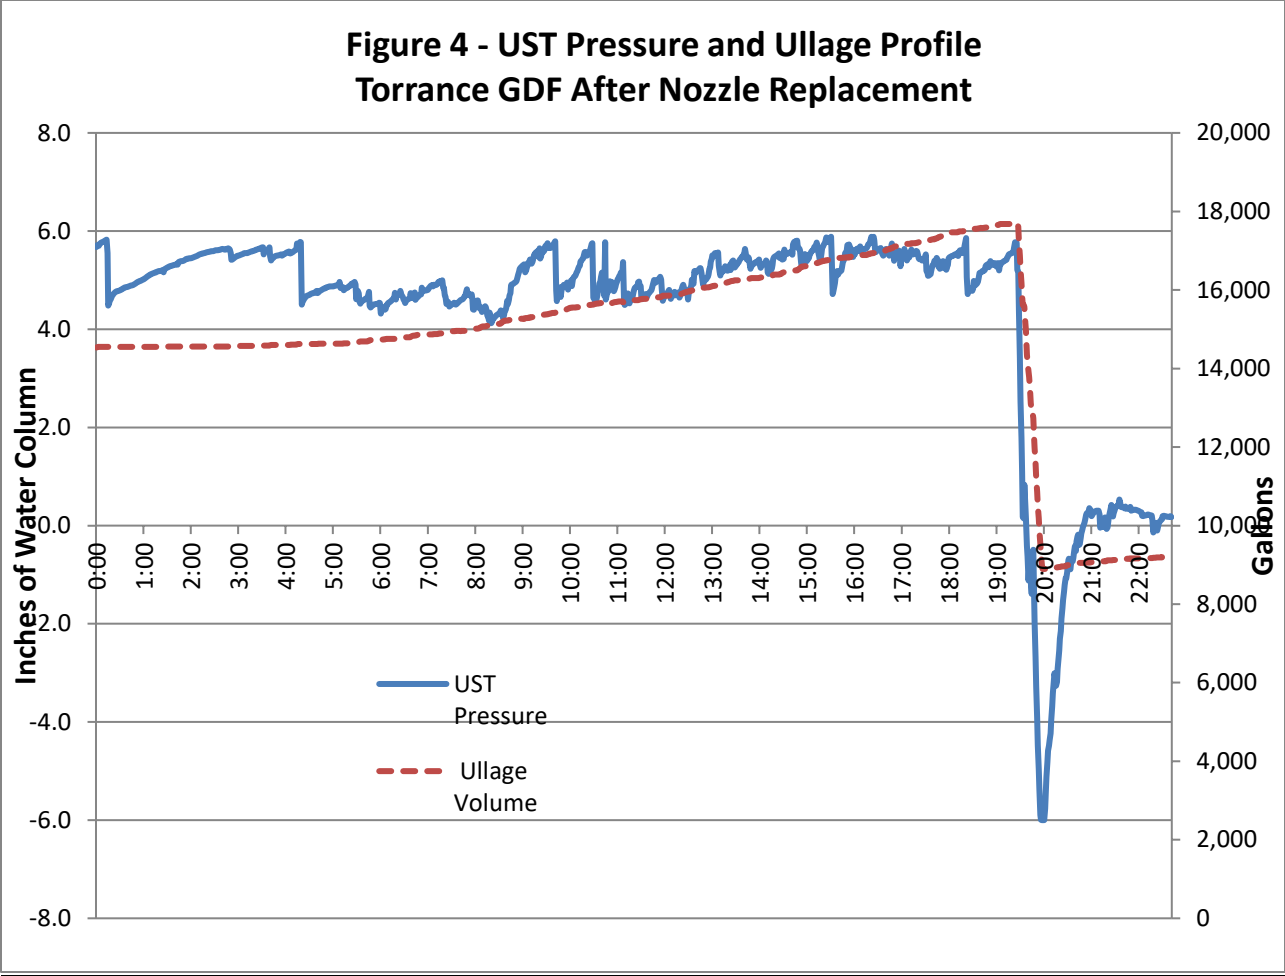
As depicted in the Figure 4 and indicated in Table 9 below, an analysis of the pressure data captured by the ISD system from November 12 through November 14 revealed that positive pressure conditions persisted for 72 hours immediately following the nozzle replacement. The daily average pressure values were still around 5 inches water column which indicates the pressure/vacuum vent valve was opening to relieve pressure. This suggests that replacing the nozzle did not affect the UST pressure.

Date	Daily Min (inches water column)	Daily Max (inches water column)	Daily Average (inches water column)	PWD?
11/12/2014	-6.0	5.9	4.3	Yes
11/13/2014	-0.1	5.8	3.6	Yes
11/14/2014	3.6	5.7	4.8	Yes
