Monitoring and Laboratory Division
Vapor Recovery and Fuel Transfer Branch
Vapor Recovery Regulatory Development Section

Report No. VR-OP-A1

OVERPRESSURE STUDY:

Technical Support Document
Results of Vapor Recovery System Performance Testing
Conducted at Gasoline Dispensing Facilities Equipped with the
Assist Phase II Enhanced Vapor Recovery System which Experience Pressure
Increase While Dispensing

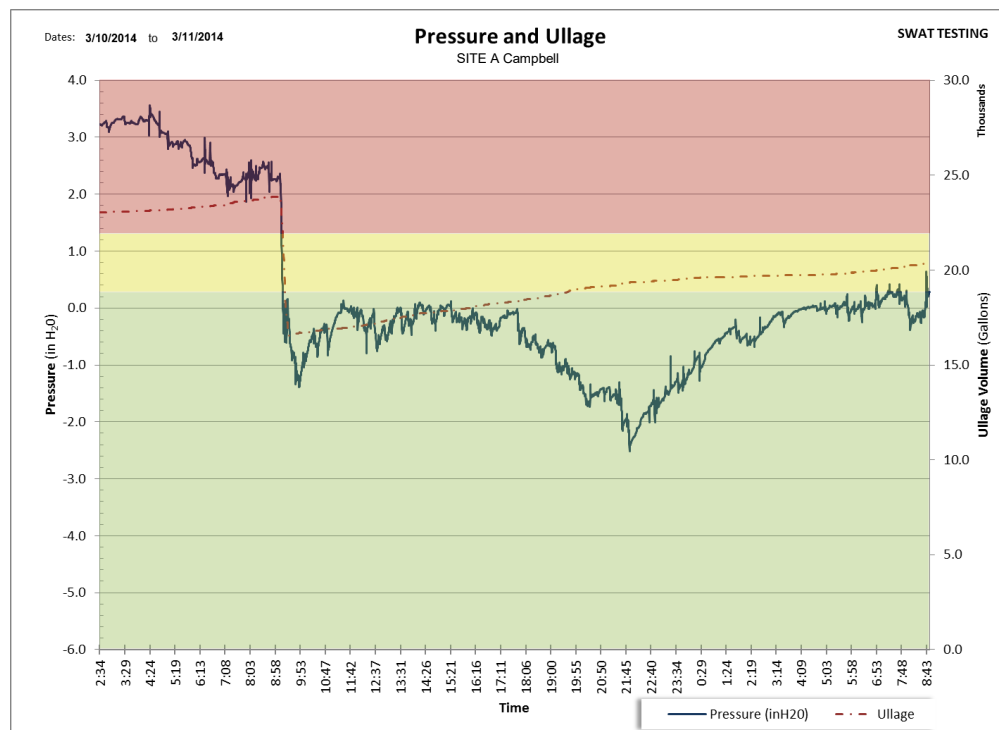
Figure IV-1: Pressure Ullage Chart – SITE A Campbell⁴

⁴ This pressure ullage chart dictates that there has been a change in RVP. Once the fuel was dropped the site went from overpressure / PWD status to a non-overpressure / non-PWD status. This site's hours of operations are from 11:00 PM to 6:00 AM, which is shown on the chart. The pressure is increasing during the non-operational hours. Also it can be said based on the chart that from 6:00 AM to 9:00 AM the as the ullage increased (fueling is occurring), the pressure is also increasing, behavior of PWD station.
