Monitoring and Laboratory Division Vapor Recovery and Fuel Transfer Branch Vapor Recovery Regulatory Development Section

Project Number: VR-11-11

Report No. VR-OP-A1

Technical Support Document Results of Vapor Recovery System Performance Testing Conducted at Gasoline Dispensing Facilities Equipped with the Assist Phase II Enhanced Vapor Recovery System which Experience Pressure Increase While Dispensing

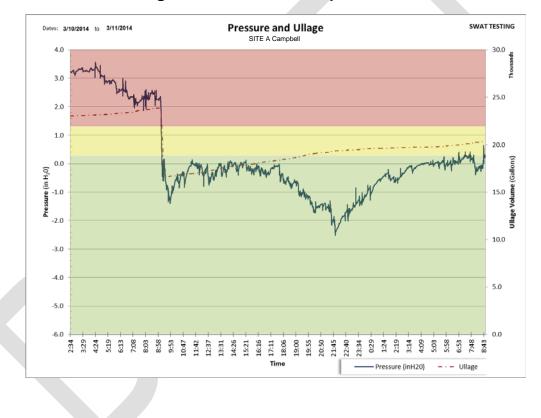
Figure IV-1: Pressure Ullage Chart – SITE A Campbell⁴

⁴ This pressure ullage chart dictates that there has been a change in RVP. Once the fuel was dropped the site went from overpressure / PWD status to a non-overpressure / non-PWD status. This site's hours of operations are from 11:00 PM to 6:00 AM, which is shown on the chart. The pressure is increasing during the non-operational hours. Also it can be said based on the chart that from 6:00 AM to 9:00 AM the as the ullage increased (fueling is occurring), the pressure is also increasing, behavior of PWD station.
