Monitoring and Laboratory Division DRAFT Vapor Recovery and Fuel Transfer Branch Vapor Recovery Regulatory Development Section

Report No. VR-OP-A2

**Overpressure Study**

Technical Support Document Nozzle Replacement Study at Gasoline Dispensing Facility Equipped with Assist Phase II Enhanced Vapor Recovery System Exhibiting Pressure Increase While Dispensing

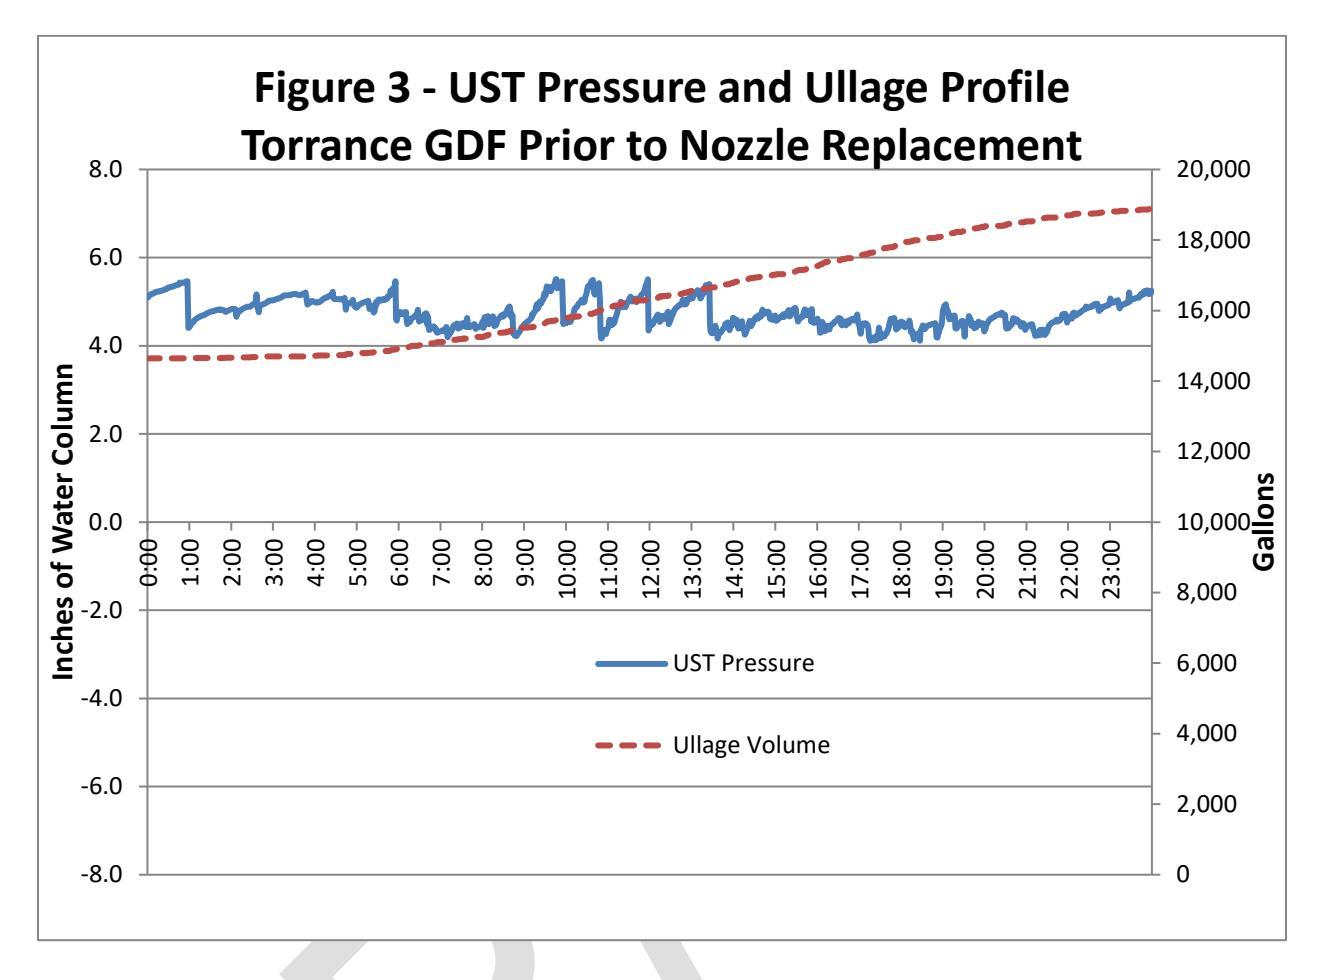
Date	Daily Min (inches water column)	Daily Max (inches water column)	Daily Average (inches water column)	PWD ?
11/5/2014	1.2	5.9	4.1	Yes
11/6/2014	1.6	5.6	3.7	Yes
11/7/2014	4.1	5.5	4.7	Yes

#### Table 8: UST Pressure Data Analysis Before Nozzle Replacement

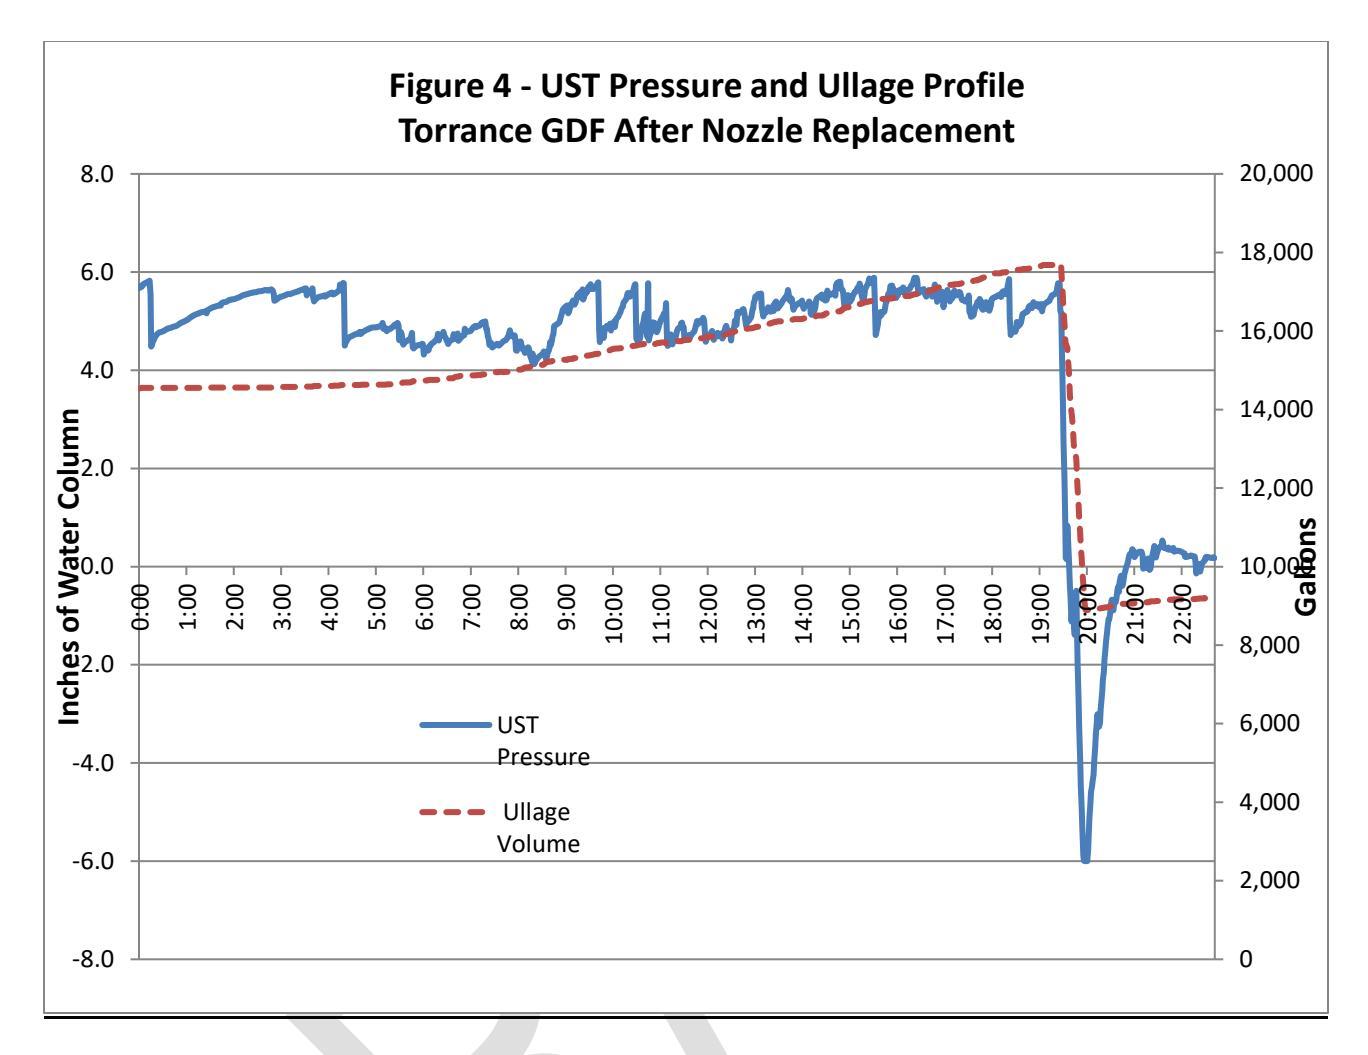
As depicted in the Figure 4 and indicated in Table 9 below, an analysis of the pressure data captured by the ISD system from November 12 through November 14 revealed that positive pressure conditions persisted for 72 hours immediately following the nozzle replacement. The daily average pressure values were still around 5 inches water column which indicates the pressure/vacuum vent valve was opening to relieve pressure. This suggests that replacing the nozzle did not affect the UST pressure.

A side by side comparison of the average daily UST pressure before and after nozzle replacement is provided in Table 10. The average UST pressure for 72 hours immediately prior to nozzle replacement was positive 4.2 inches water column. The average UST pressure for the 72 hours immediately following the nozzle replacement (which occurred on 11/12/14) was 4.3 inches water column. The installation of new nozzles did not change the average daily UST pressure. This provides evidence that nozzle replacement was not effective in mitigating or preventing overpressure.
