Overpressure Study

Technical Support Document

Healy Model 900 Assist Vapor Recovery Nozzle
ORVR Vehicle Recognition Study

November 29, 2017

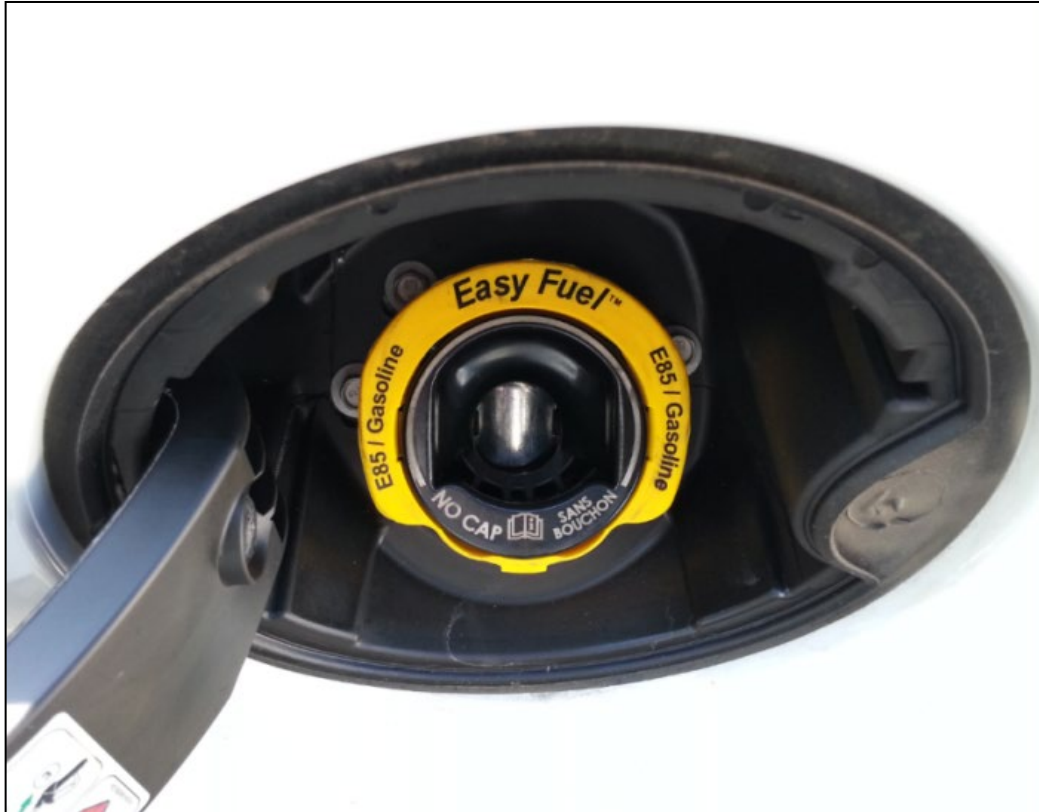
Figure V-3
Capless Fill Pipe System

from a traditional capped fill pipe system to a capless fill pipe system. Figure V-3 shows an example of a capless fill pipe system.

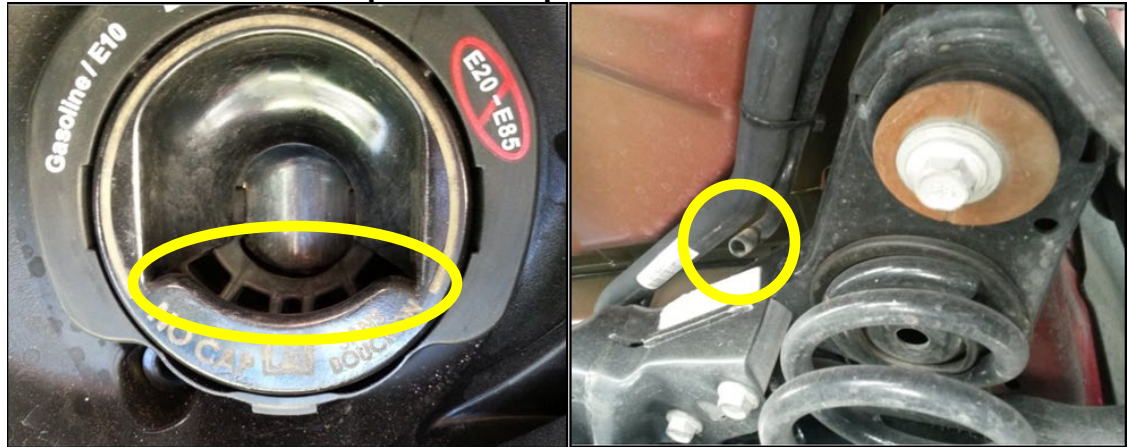
Figure V-4
Capless Fill Pipe Drain Port

Some capless fill pipe systems were designed with a drain port that prevents water, dirt, and dust from entering the fuel pipe. The drain port extends from the fill pipe to the bottom of the vehicle. Figure V-4 shows an example of the drain port in the capless fill pipe and at the underside of the vehicle.

When fueling an ORVR equipped vehicle with a capless fill pipe with a Healy nozzle, fresh air is allowed to enter the nozzle bellows from the drain port underneath the vehicle. During this fueling, no vacuum is created in the nozzle bellows and there is no restriction of the vapor path in the nozzle. As a result, a V/L ratio of greater than one may occur. The fresh air that is allowed to enter through the drain port is returned to the UST which increases the pressure in the UST due to gasoline evaporation.
