Project Number: VR-11-11  
Report Number: VR-OP-A5

## Overpressure Study

Technical Support Document:  
Evaluation of Healy Model 900 Assist Vapor Recovery Nozzle  
with Enhanced On-Board Refueling Vapor Recovery (ORVR)  
Vehicle Recognition Feature during the Winter of 2015/2016

November 28, 2017

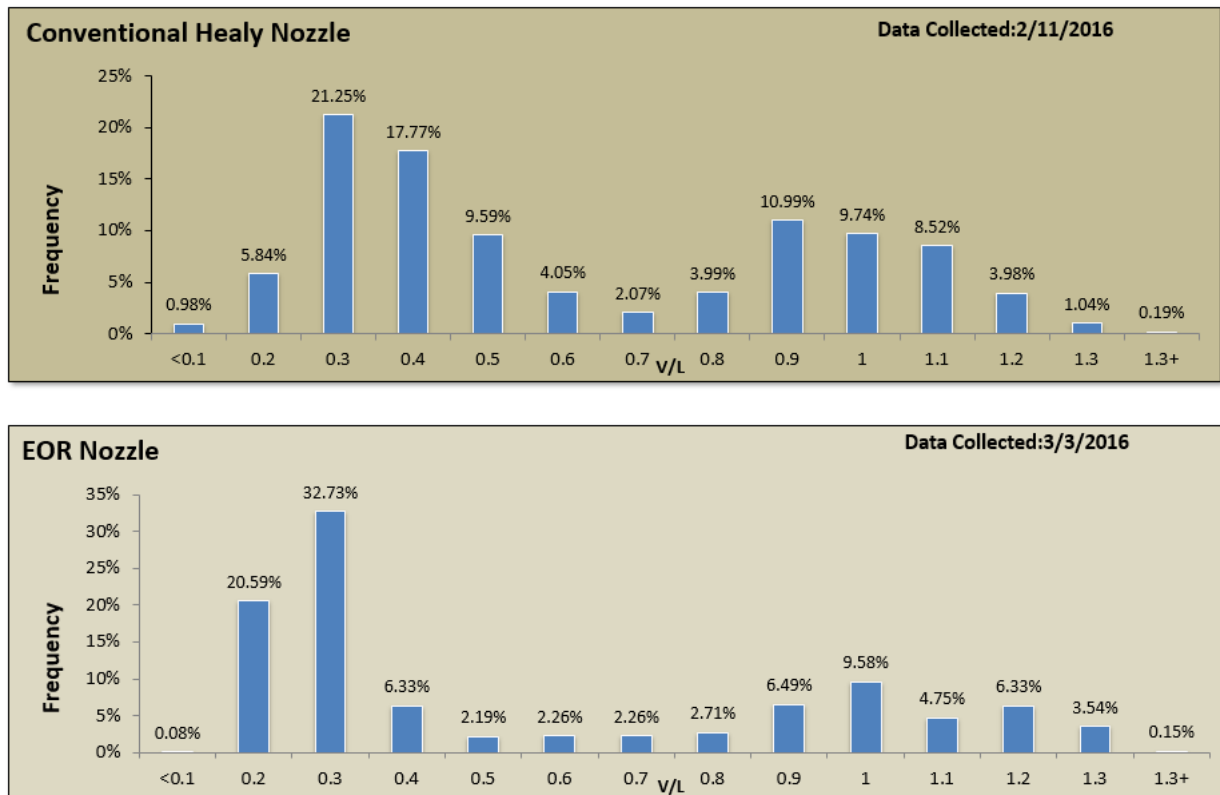
**Figure IV-7: Gilroy - V/L Histograms for Conventional and EOR Nozzle**

Figure IV-7 provides the histograms comparing the Gilroy test site V/Ls for the conventional Healy nozzle and the EOR nozzle. The EOR nozzle generates a lower percentage at 0.6 and 0.8 V/L, and a higher percentage at 0.3 V/L. As with the histogram generated for Campbell, the frequency of V/L in the range 0.4 to 0.8 was also reduced.
