Project Number: VR-11-11

Report Number: VR-OP-A7

## **OVERPRESSURE STUDY**

Technical Support Document:  
Evaluation of Healy Model 900 Assist Vapor Recovery Nozzle with  
Enhanced On-Board Refueling Vapor Recovery (ORVR) Vehicle  
Recognition Feature during the Winter of 2016/2017

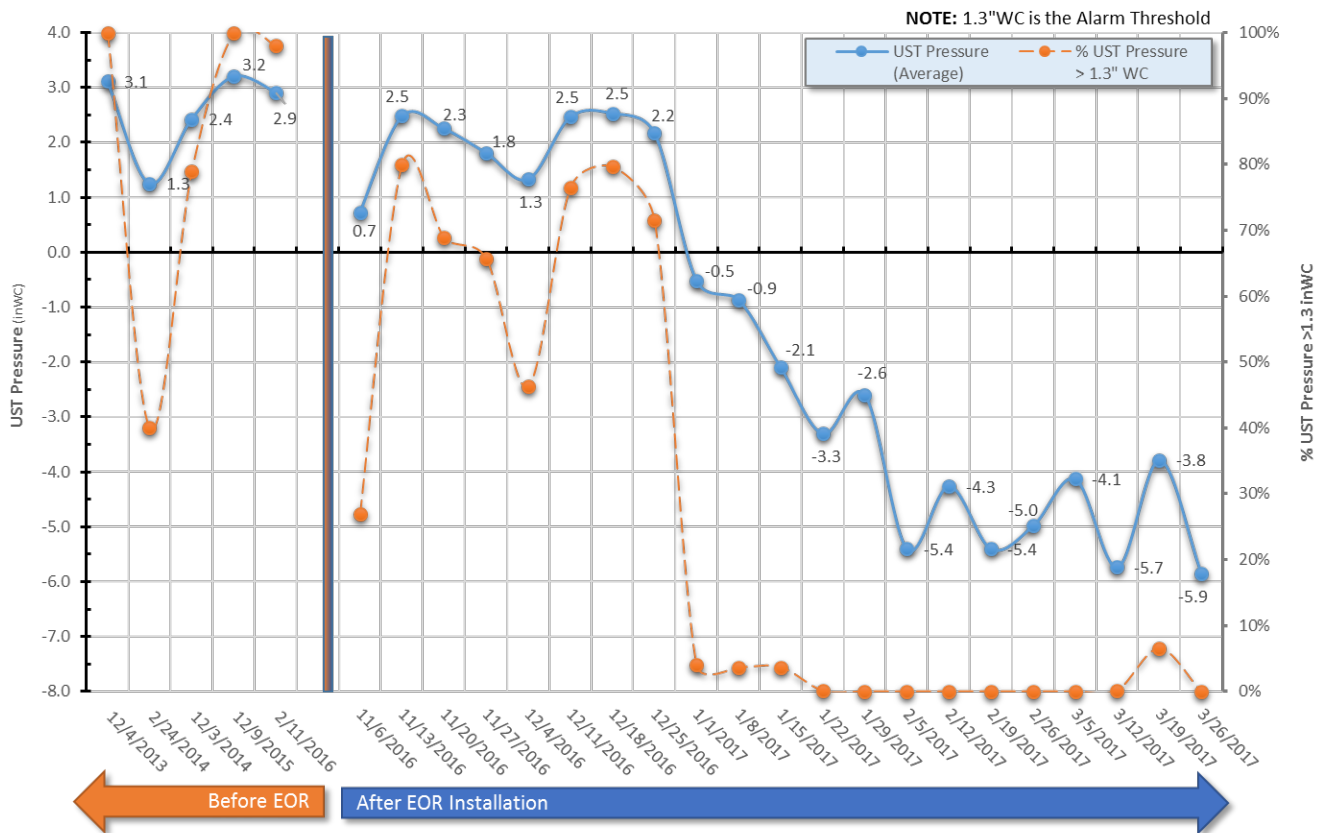
**FIGURE V-7: Weekly Average UST Pressure – Campbell**

Table V-4 provides a comparison of UST pressure data with the currently certified nozzle and UST pressure data with the Healy 900 nozzle with EOR spout. Please note, the timeframes and duration are not identical as the historical data was collected from prior site visits and the EOR nozzle data was collected after the installation of a CARB data acquisition system along with EOR nozzles. The

\* Pressure averages for Pre EOR spout is based on 30 hours of data, gathered during the Mega Blitz of 2013/2014/2015. EOR spout average is based on weekly averages between mid-November to end of February 2017
