Project Number: VR-11-11

Overpressure Study

Technical Support Document

Healy Model 900 Assist Vapor Recovery Nozzle
ORVR Vehicle Recognition Study

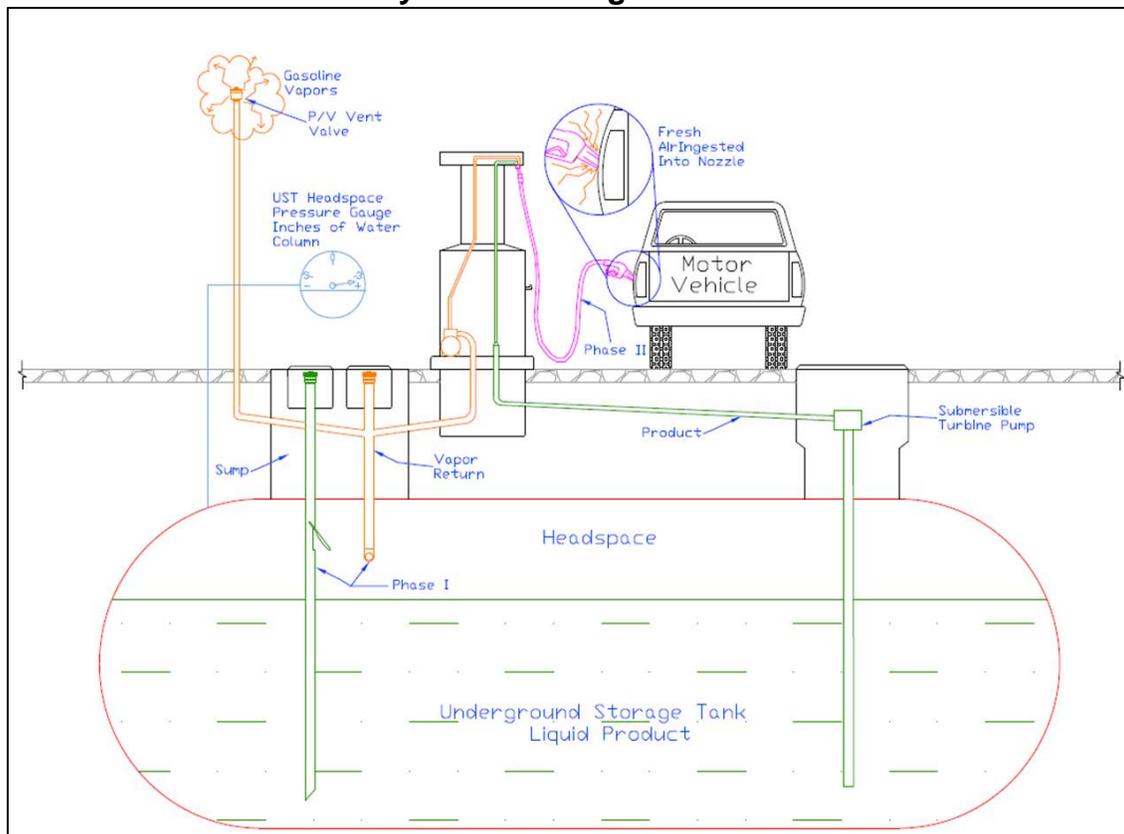
The Assist System is designed to reduce the volume of vapor collected relative to the volume of liquid dispensed when fueling ORVR vehicles. For the Assist System to work properly, the Healy nozzle must limit the amount of air ingestion during the fueling of ORVR vehicles. This is referred to as ORVR recognition and relies upon a tight seal being formed at the nozzle and vehicle fill pipe interface. The vapor volume available for collection by the nozzle is limited and thus a vacuum rapidly develops in the nozzle bellows. This vacuum activates a diaphragm which restricts the vapor return path in the nozzle which drops the vapor to liquid ratio (V/L) below 0.5 when fueling ORVR vehicles. In some instances, an ORVR fueling will result in an elevated ORVR V/L (>0.5) due to excess air ingestion by the nozzle during the fueling process. This excess air will be returned to the UST, resulting in higher evaporation rates and vapor growth in the UST leading to OP containment alarms and excess pressure-

driven emissions. Figure II-1 provides an illustration of air ingestion by a nozzle at a GDF equipped with an Assist System.

Figure II-1
Assist System – Air Ingestion at Nozzle

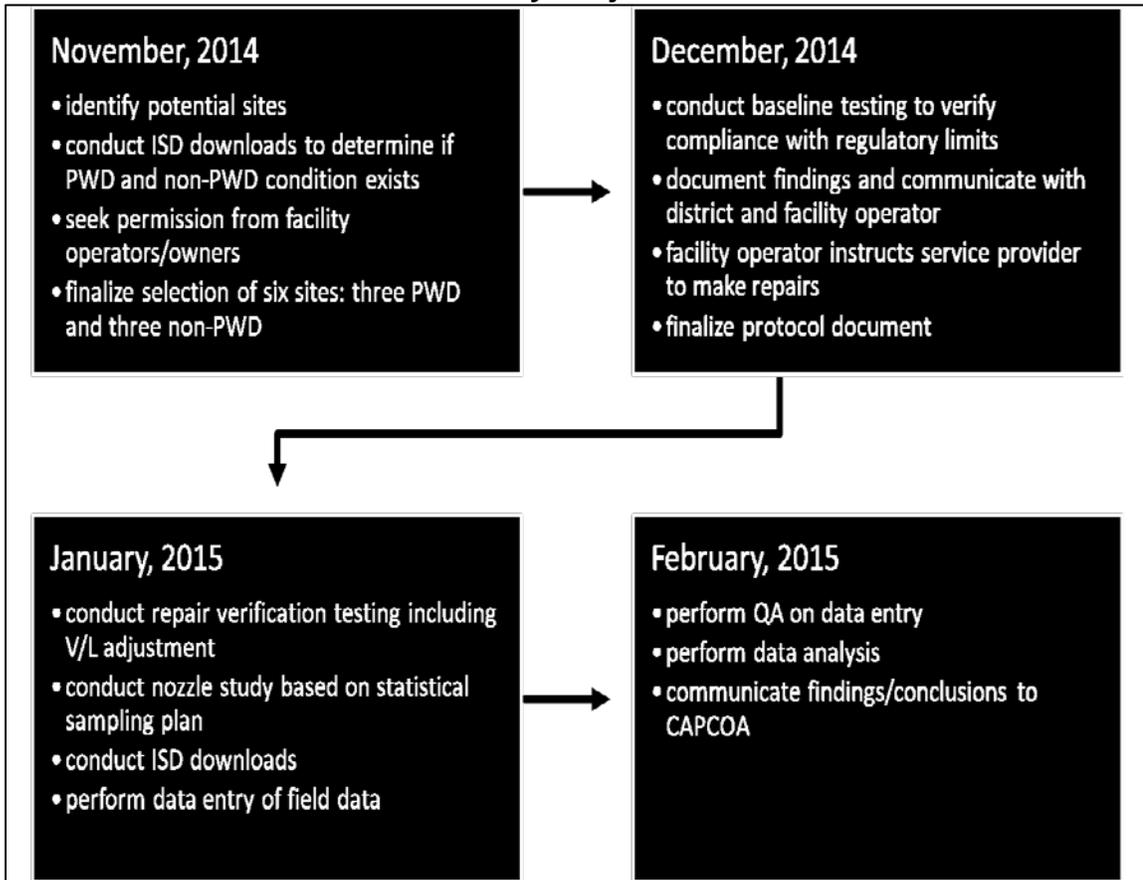
**Figure III-2
Nozzle Study Project Timeline**

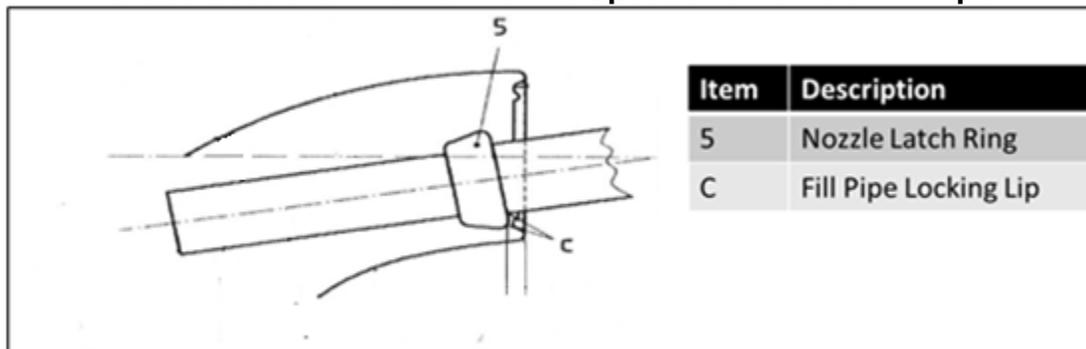
Figure V-1
Cross Sectional View of Nozzle Spout and Vehicle Fill Pipe

The nozzle spout has a latch ring which needs to securely engage upon the locking lip of the vehicle fill pipe during fueling in order to ensure a secure latch. During the nozzle study and in a subsequent CARB study⁵, field data showed that many different vehicle makes and models were able to be fueled with a

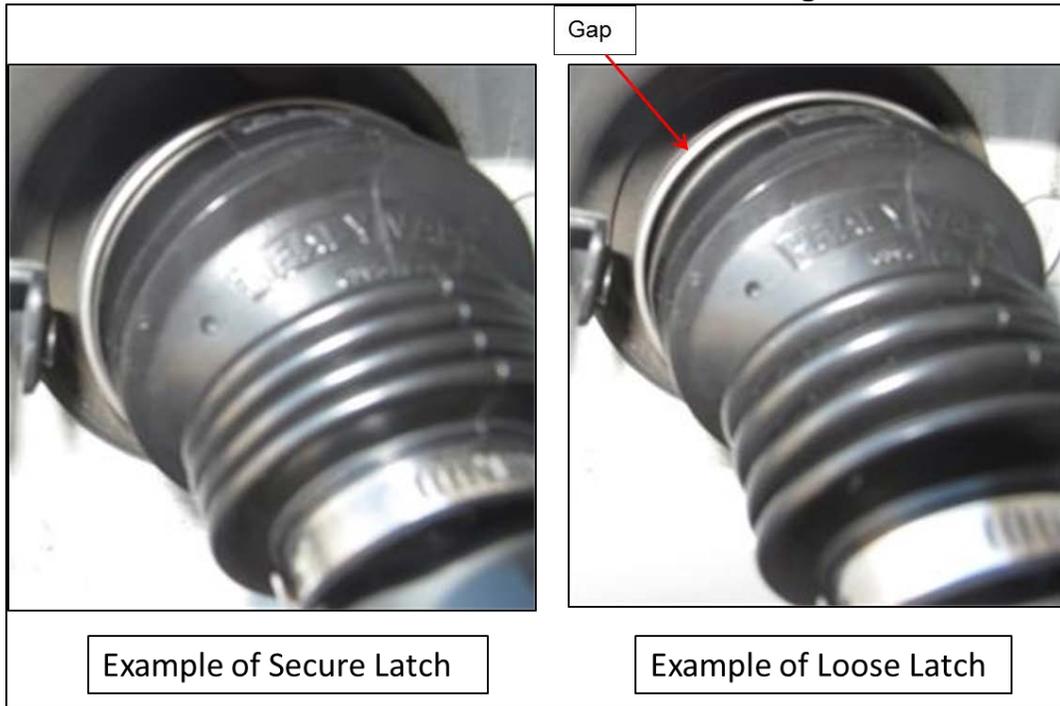
loose latch. The term loose latch means that the nozzle is not fully engaged or securely connected to the fill pipe locking lip of the vehicle fill pipe. Figure V-2 illustrates an example of a secure and loose latch fueling into an ORVR vehicle fill pipe.

Figure V-2
Secure Latch vs Loose Latch Fueling

Figure V-2 shows an example of an obvious loose latch during the fueling of an ORVR vehicle. In most cases, the loose latch cannot be visually seen but can be determined by the V/L measurement. This finding prompted the need for a field study focused on the fueling of ORVR vehicles with the nozzle securely and loosely latched into the vehicle fill pipe⁵. This field study was conducted by CARB staff at a retail GDF in Sacramento. Fueling of ORVR vehicles with a loose latch exhibited a higher V/L ratio measurement due to excess air ingestion at the fill pipe/nozzle interface. The additional air ingestion via the fill pipe/nozzle interface increases the evaporation rate and vapor growth within the UST which leads to excess pressure-driven emissions. ORVR vehicles that are fueled with a loose latch will have high V/Ls and thus result in a high mis-id rate.

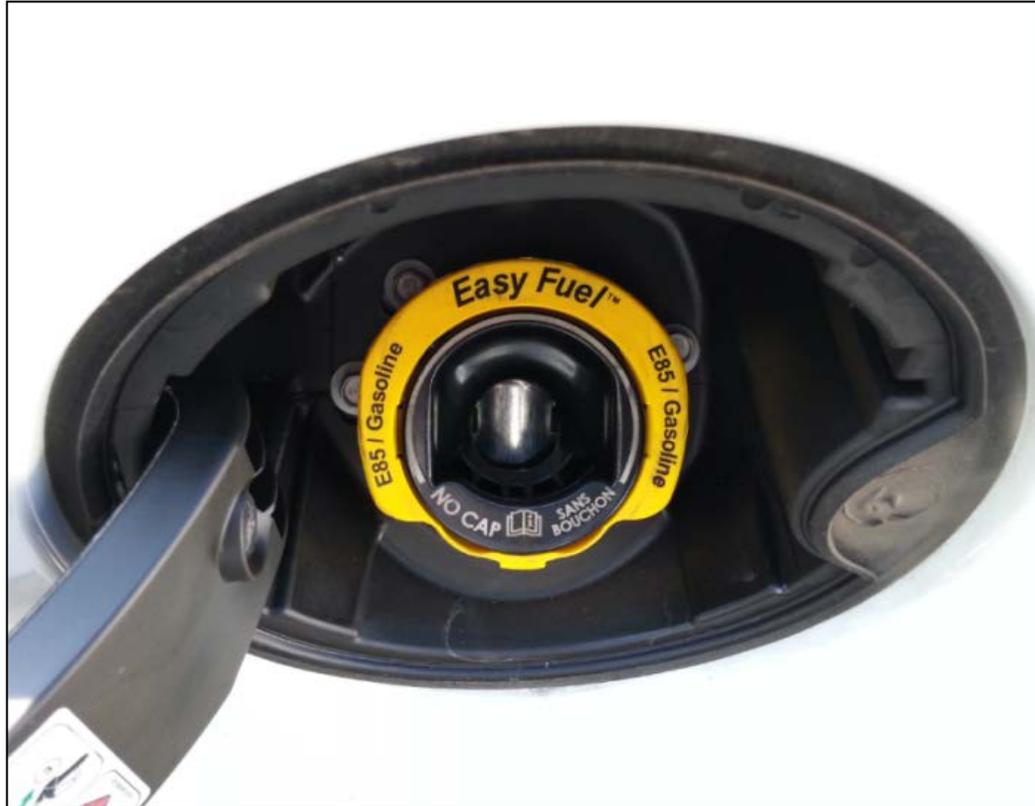
CARB's motor vehicle regulations require automotive manufactures to design vehicle fill pipes according to standards and specifications which ensure a good seal is established between the nozzle and vehicle fill pipe interface. In 2008, new vehicle fill pipe designs entered the market. Many manufacturers moved from a traditional capped system to a capless fill pipe system. Figure V-3 shows an example of a capless fill pipe system.

**Figure V-3
Capless Fill Pipe System**

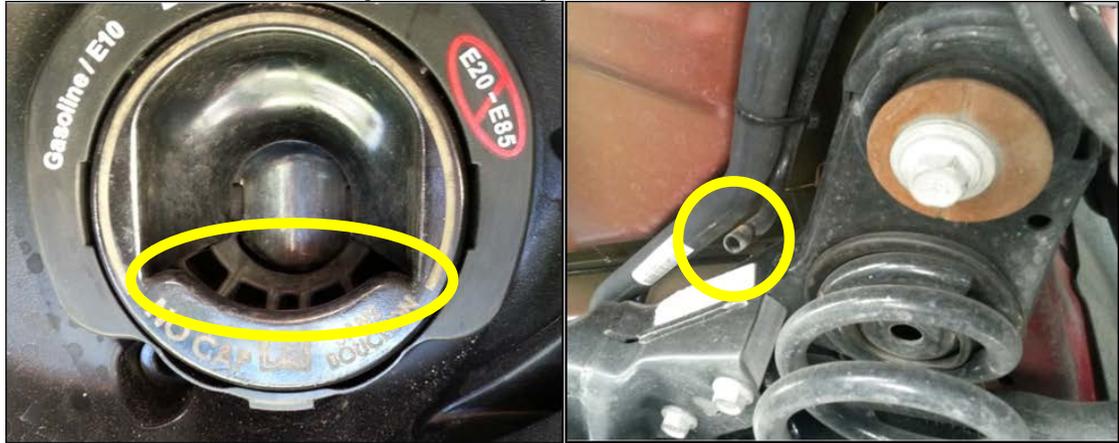
These capless fill pipe systems were designed with a drain port that prevents water, dirt, and dust from entering the fuel pipe. The drain port extends from the

fill pipe to the bottom of the vehicle. Figure V-4 shows an example of the drain port in the capless fill pipe and at the bottom of the vehicle.

Figure V-4
Capless Fill Pipe Drain Port

When fueling an ORVR vehicle with a capless fill pipe with a Healy nozzle, fresh air is allowed to enter the nozzle bellows from the drain port underneath the vehicle. During this fueling, no vacuum is created in the nozzle bellows and there is no restriction of the vapor path in the nozzle. As a result, a V/L ratio of greater than one may occur. The fresh air that is allowed to enter through the drain port is returned to the UST which increases the pressure in the UST due to gasoline evaporation.

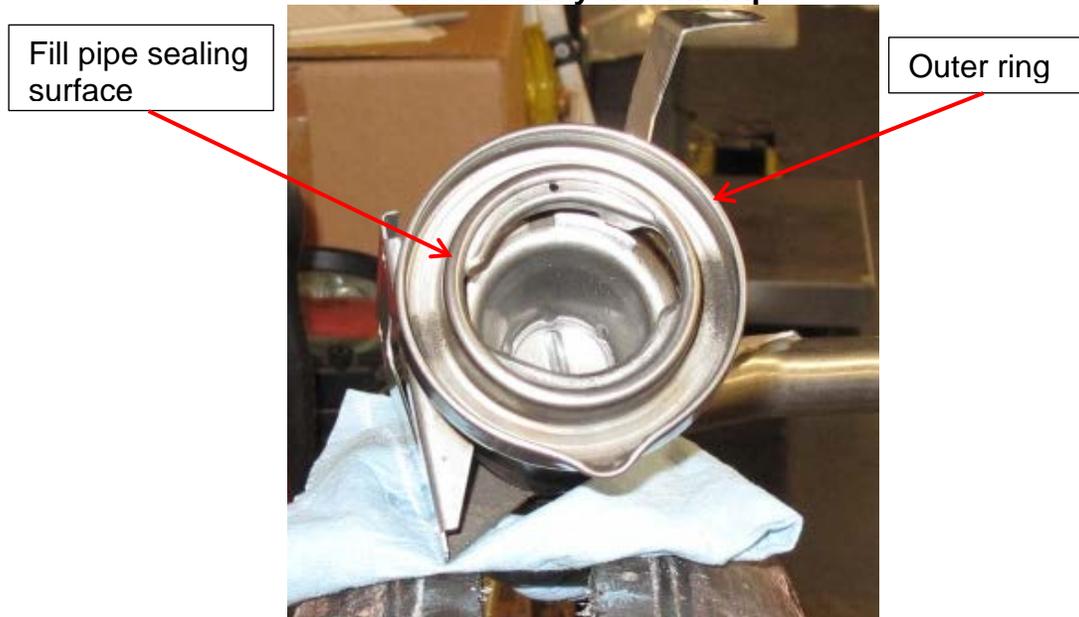
91% of the Mercedes vehicles surveyed were equipped with a bayonet fill pipe design. The Mercedes vehicles with a bayonet fill pipe also had a mis-id rate of approximately 91%. A picture of the bayonet fill pipe is shown in Figure V-5.

Figure V-5
Mercedes Bayonet Fill Pipe

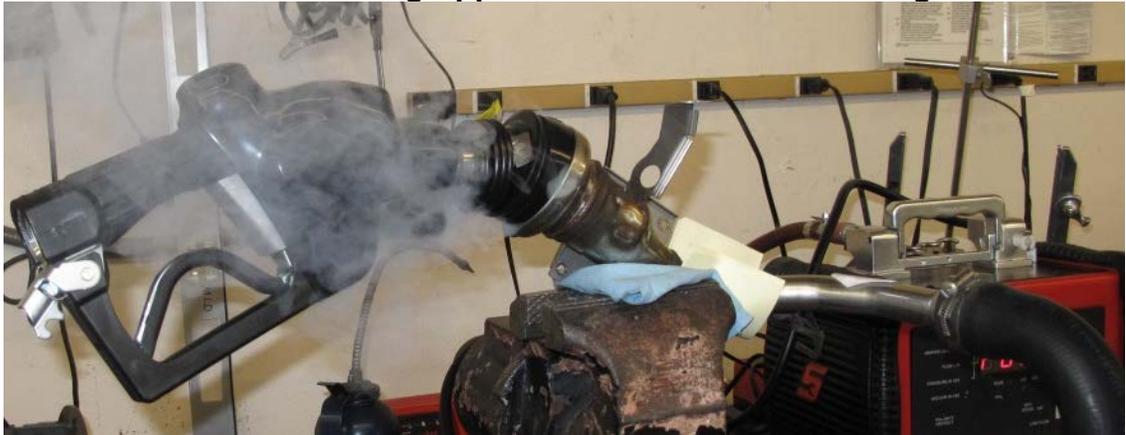
The fill pipe was tested in a lab by using a bayonet fill pipe which was removed from a Mercedes vehicle. The nozzle was then securely latched into the fill pipe. A smoke leak detector was connected to the open end of the fill pipe to determine whether the nozzle/fill pipe interface was a secure or loose latch. The smoke testing revealed that if the nozzle sits on the outer ring of the fill pipe, which is a common occurrence during vehicle fueling, the bayonet fill pipe can inhibit the Healy 900 vapor recovery nozzle from making a good seal at the bottom of the fill pipe sealing surface. The loose latch created during the fueling of a Mercedes vehicle with a bayonet fill pipe is the main cause of the high mis-id rate for vehicles equipped with this design. Figure V-6 shows the set up used to test the Mercedes bayonet fill pipe for leaks.

**Figure V-6
Smoke Testing Apparatus Used for Leak Testing**

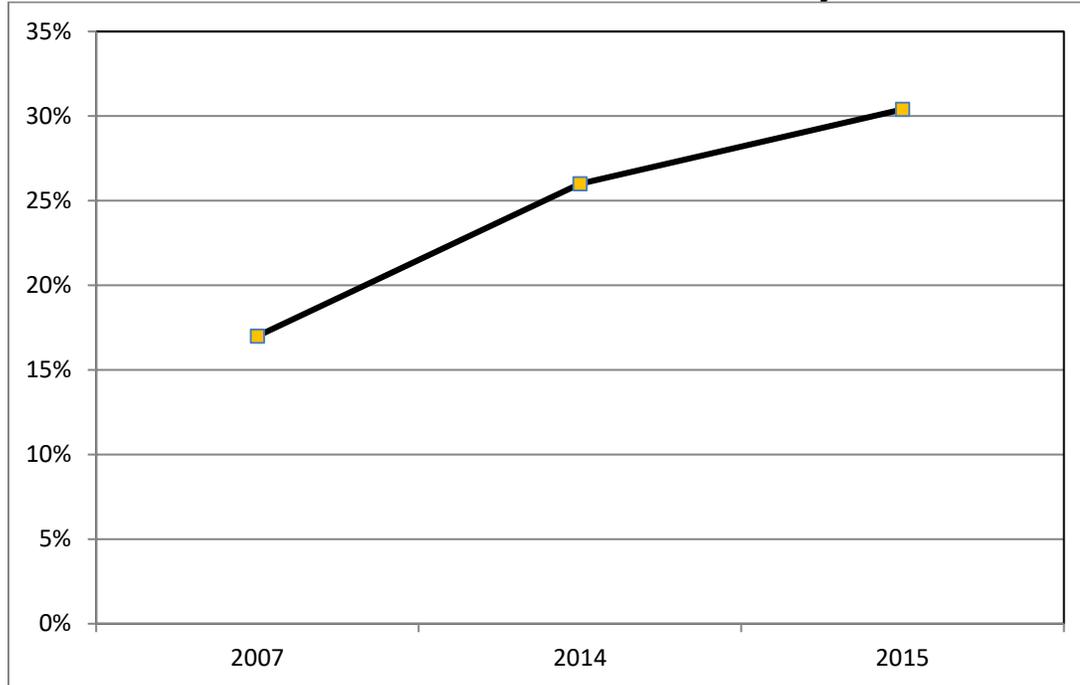
Over the last eight years, three studies pertaining to Healy nozzle ORVR recognition have been conducted; two collaboratively between CARB and CAPCOA staff and one by San Diego County Air Pollution Control District staff. In each of these three studies, only the fueling of vehicles was observed and customers were not assisted during the fueling process. Figure V-7 shows the increasing trend in the mis-id rate for the three studies conducted since 2007.

**Figure V-7
Trends in ORVR Vehicle Mis-ID Rate of Healy Nozzle**

In 2007, CARB and CAPCOA staff conducted an 18 month In-Use ISD Evaluation Field Study on the first ISD system certified by CARB in which the fueling of 547 ORVR vehicles was observed. The results of this study showed that the mis-id rate for ORVR vehicles was approximately 17%. In June 2014, a small ORVR Recognition Study was conducted by San Diego County Air Pollution Control District staff in which the fueling of 96 ORVR vehicles was observed. The mis-id rate for this study was determined to be approximately 26%. The small ORVR Recognition Study led to the larger nozzle study conducted in San Diego in January 2015 by CARB and CAPCOA staff. From this latest nozzle study, the mis-id rate was determined to be approximately 30% (Table IV-2).
