Project Number: VR-11-11

OVERPRESSURE STUDY

Technical Support Document

Evaluation of Assist Vapor Recovery Nozzle ORVR Vehicle Recognition
Performance Under Controlled Fueling Conditions

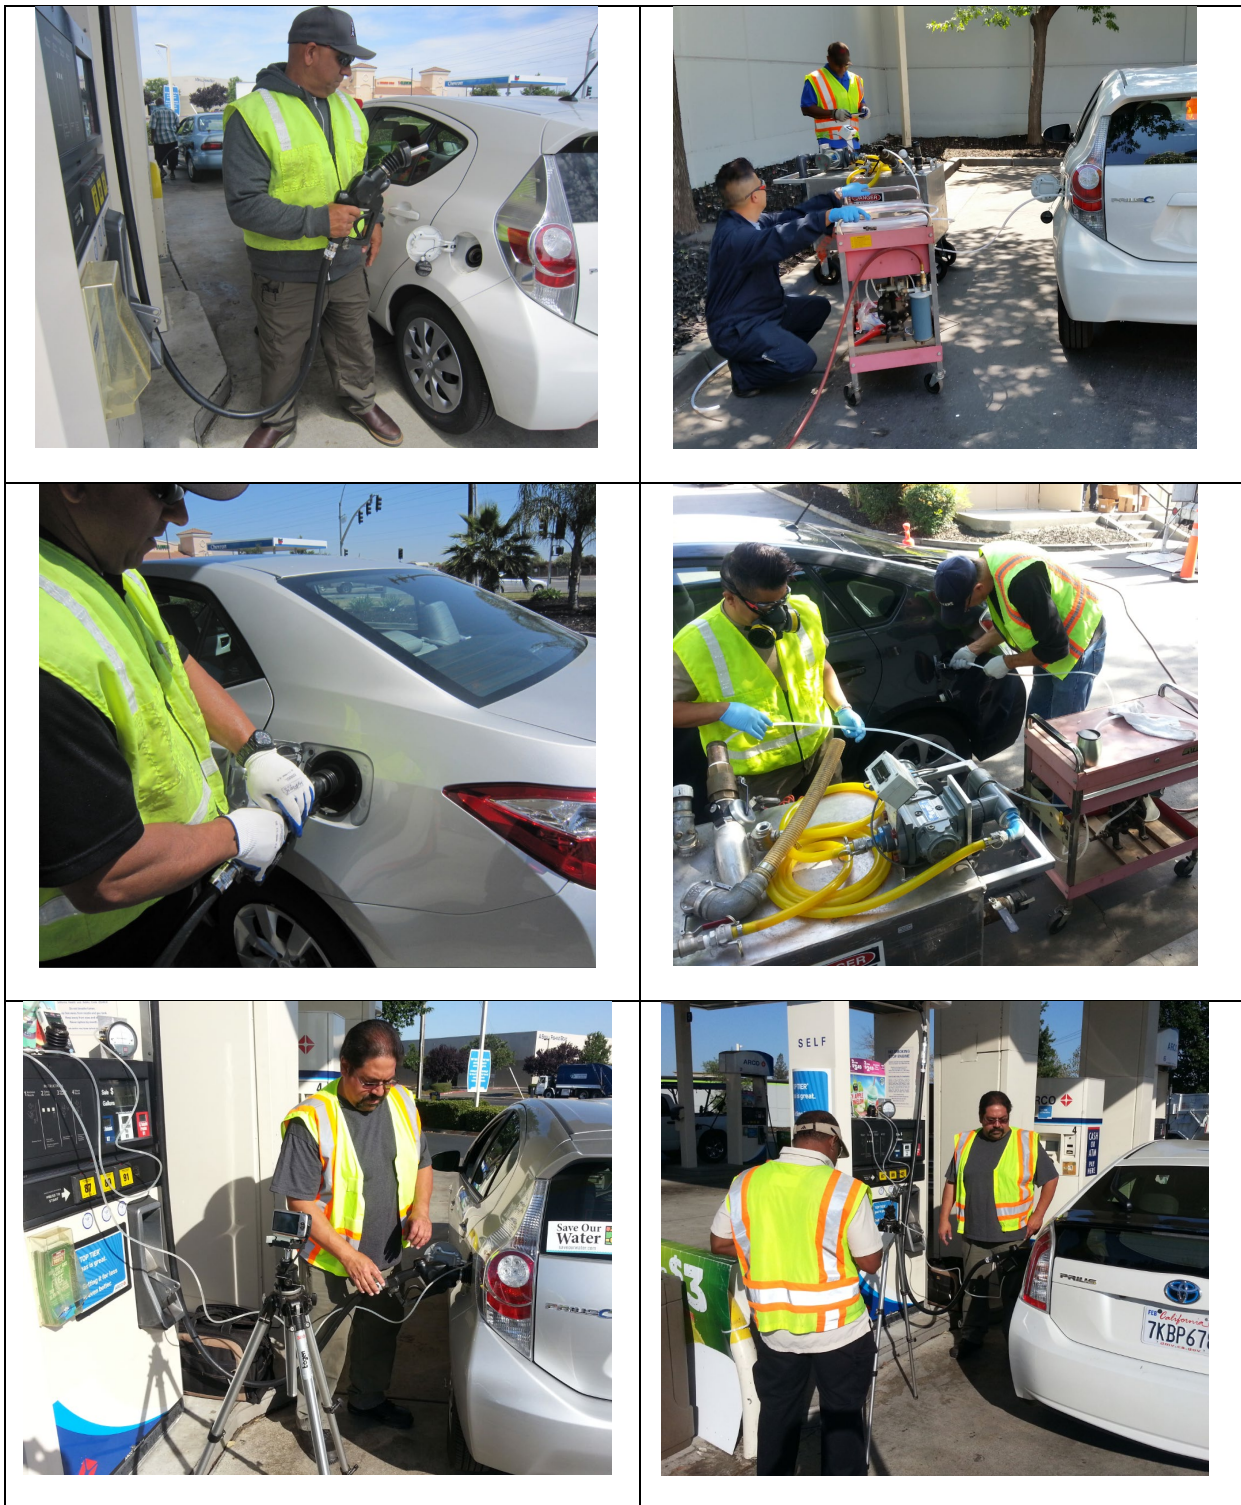
Figure III-3: Images of Test Site and Motor Vehicle Fuel Syphoning System

It should also be noted that rather than paying for the gasoline dispensed for each fueling event, the GDF operator authorized each fueling as a “pump test” (typically done to accommodate county weights and measures or to accommodate vapor recovery testing) in which the gasoline will be returned to the underground storage tank after the test is completed. Images of vehicles being test, the fueling position, the vapor recovery nozzle, and the motor vehicle fuel siphoning system are provided in figure III-3
