# **Evaluation of the Potential Impact of Emissions of HFC-134a From Non Professional Servicing of Motor Vehicle Air Conditioning Systems**

Provisional Final report

**ANNEXES**

June 2008

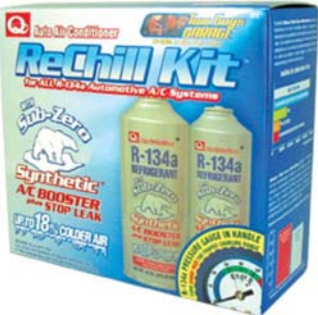
QUEST ReChill Kit	S&P	2 x18 oz. of R-134a 4 Oz of Sub-Zero Synthetic A/C Booster

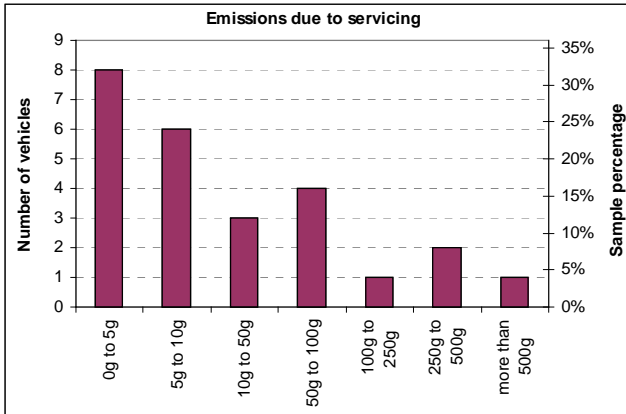
Figure A.1: Number of vehicles as a function of emission range due to servicing (sample 1).

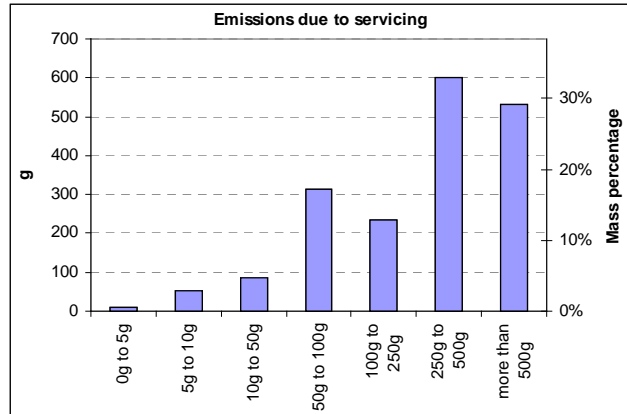
Figure A.2: Mass emission as a function of emission range due to servicing (sample 1).

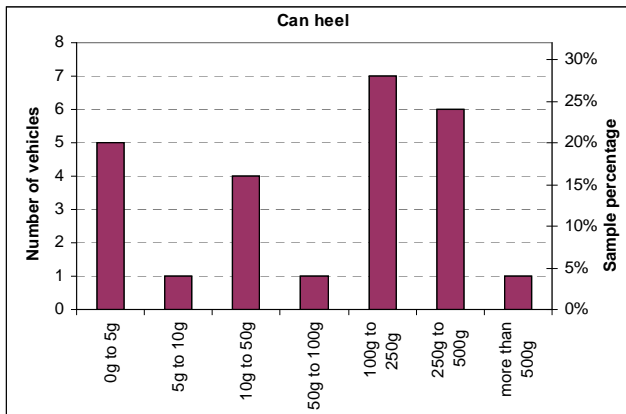
Figure A.3: Number of vehicles as a function of can heel range (sample 1).

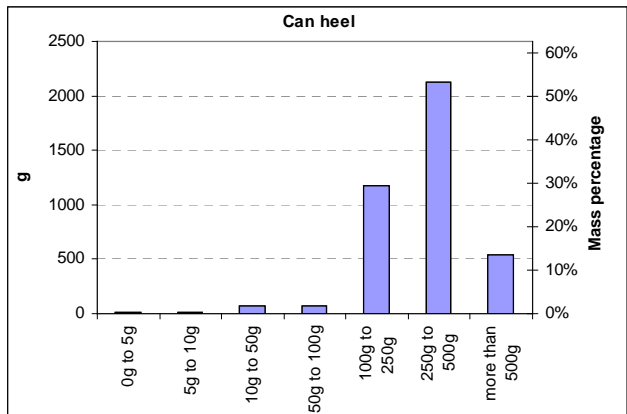
Figure A.4: Mass emission as a function of can heel range (sample 1).

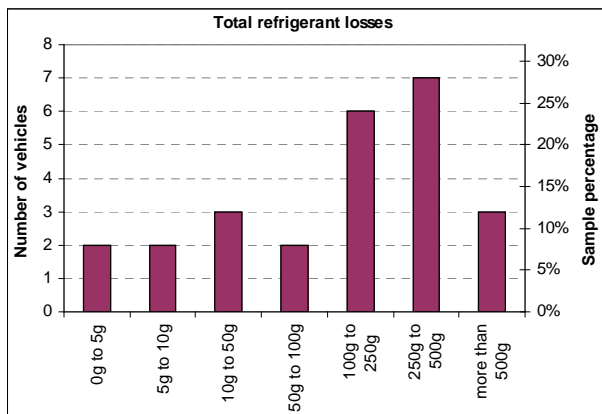
Figure A.5: Number of vehicles as a function of total refrigerant emissions (sample 1).

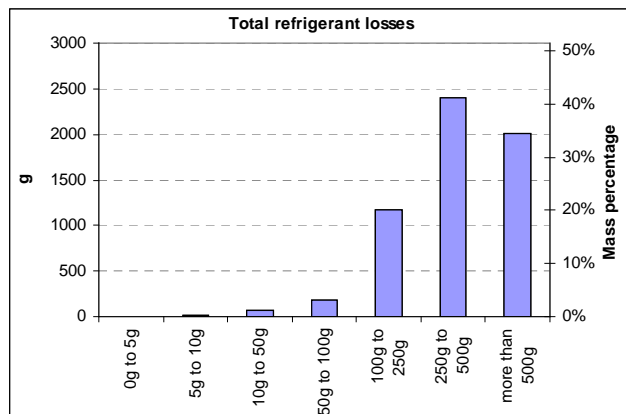
Figure A.6: Mass emission as a function of total refrigerant emissions (sample 1).

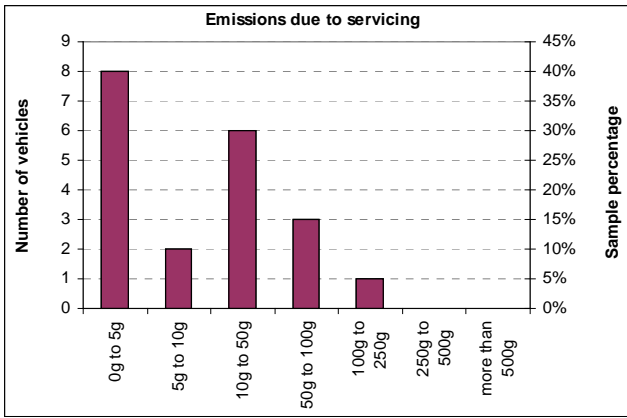
Figure A.7: Number of vehicles as a function of emission range due to servicing (sample 2).

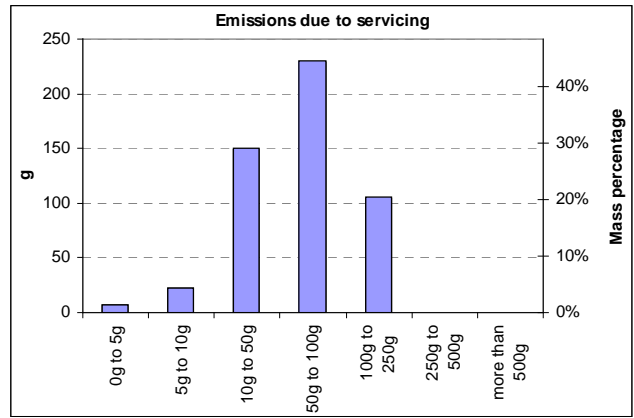
Figure A.8: Mass emission as a function of emission range due to servicing (sample 2).

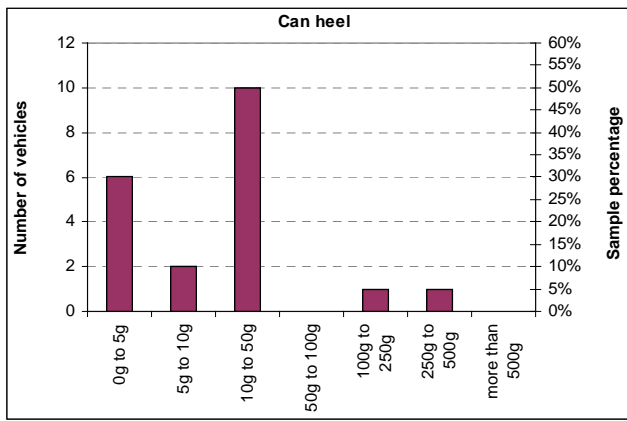
Figure A.9: Number of vehicles as a function of can heel range (sample 2).

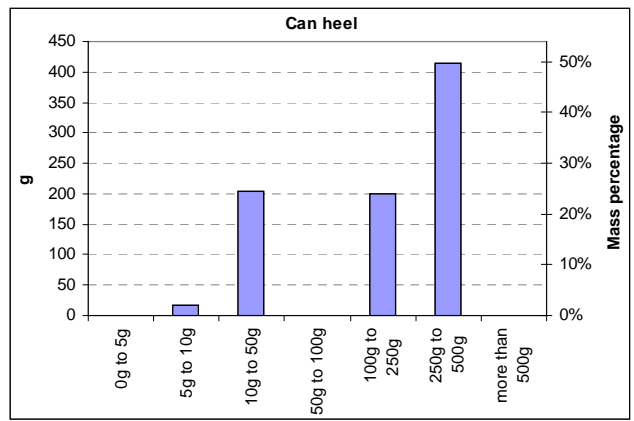
Figure A.10: Mass emission as a function of can heel range (sample 2).

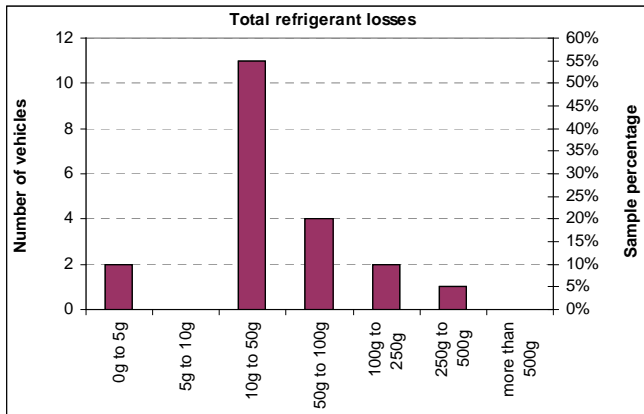
Figure A.11: Number of vehicles as a function of total refrigerant emissions (sample 2).

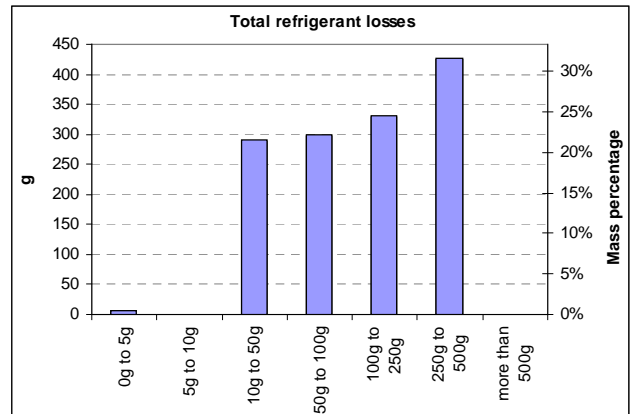
Figure A.12: Mass emission as a function of total refrigerant emissions (sample 2).
