Volvo Group North America

Re: Volvo Group Comments to Proposed Revisions to On-Board Diagnostic System Requirements for Heavy-Duty Engines, Passenger Cars, Light-Duty Trucks, Medium-Duty Vehicles and Engines

Comments on FRO 1968.2 (Proposed 15-Day Notice)

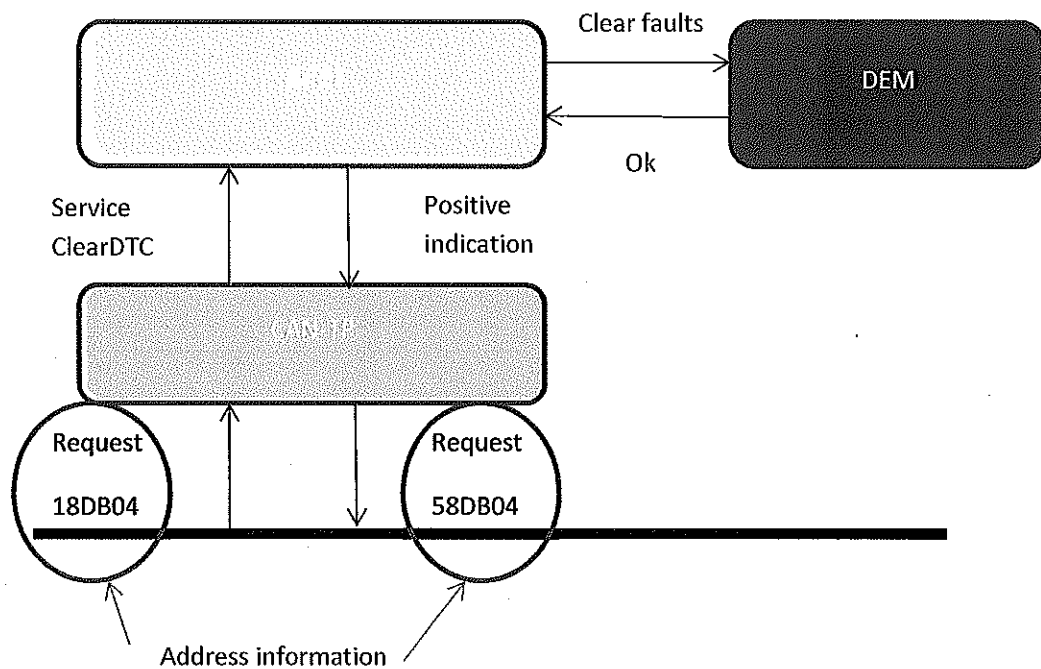
Figure 1: Example of OSI-layering in modern diagnostic software.

The technical side is that most ECU diagnostic communication software is built around OSI-layers, there is one module getting the CAN frames and transmitting a diagnostic service message to the upper layer of the software. The diagnostic communication module (DCM) receives the message without knowing the sender or how it was sent (physically or functionally). The DCM executes the service message and sends the response back to the lower layers which will truncate the message into CAN-frames and send to the tool (See Figure 1). It will be a technical burden to "hack" the OSI-stack in order to let the service "Clear DTC" to know how it was addressed, for just one of the services. Many OEMs base their software implementations on functionality defined by Autosar and this change will cause an update of the Autosar platform or software workarounds done by the system supplier, and some of the standard documents (e.g. SAE J1979, ISO 14229, ISO 27145) may need to be updated.
