State of California  
AIR RESOURCES BOARD

EXECUTIVE ORDER D-60  
Relating to Exemptions under Section 27156  
of the Vehicle Code

SUPERIOR INDUSTRIES, INC.

"ACCULITE ELECTRONIC RETROFIT IGNITION SYSTEM - MODEL NO. G8-24 AND A8-34"

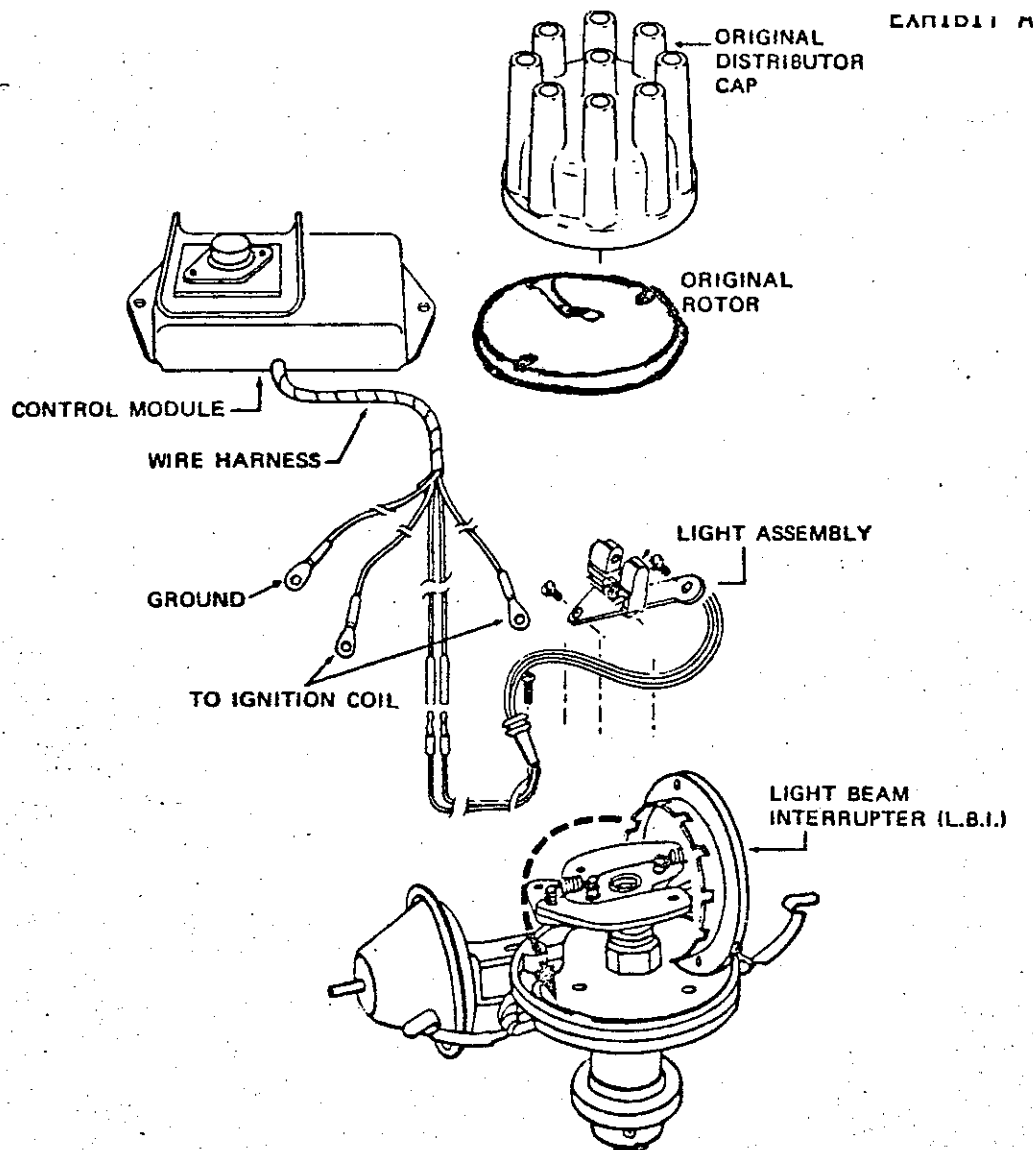
Superior has now developed such a breakerless ignition system as an aftermarket item so that it can be fitted to vehicles which originally were equipped with contact points. The owner of an automobile equipped with a breakerless electronic ignition system will find that the advantages of such a system are: greater reliability, more precise cylinder to cylinder timing, more precise firing characteristics, usually a hotter spark, and always a significant decrease in maintenance and service costs since there are no parts to wear out or alter ignition timing. This results in less frequent increases in harmful emissions because of point wear.

The Superior Industries, Inc. electronic ignition system is a unit to replace the breaker points within a distributor. It consists primarily of a light emitting diode and photocell sensor, a light beam interrupter, and an electronic control module. The light emitting diode and photocell operate in conjunction with the light beam interrupter to generate an ignition timing signal. The ignition signal is fed to the electronic control module which accomplishes transistor switching of the primary coil in the ignition system.

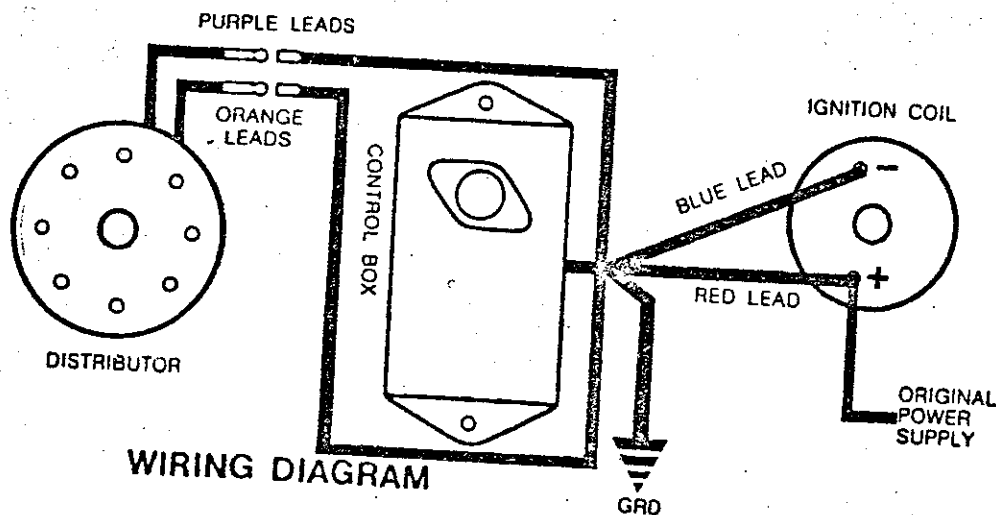
1. Remove distributor cap — check for cracks or burnt electrodes — replace if found defective.
2. Remove rotor hold screws and remove rotor. Check for burnt or oxidized contacts, replace if necessary. Discard original hold down screws — use new screws and flat washers supplied in package when reassembling.

3. Disconnect distributor lead from contact points, remove points. It may be necessary to crank engine to position centrifugal advance to remove hold down screws. Remove condenser and condenser bracket screw.

4. Remove distributor lead from negative (-) terminal on the ignition coil and pull it out of the distributor completely.
5. Insert orange and purple wires individually through the distributor housing hole.

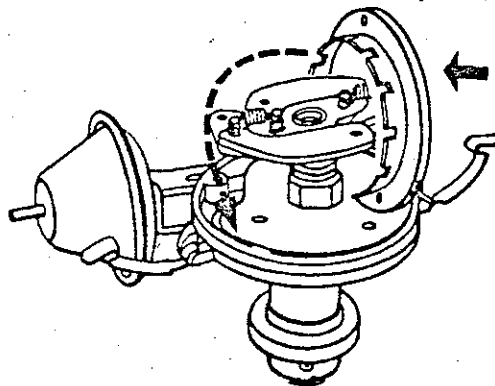
6. Position light device on base plate of the distributor. **DO NOT** align light device into its proper place at this time.
7. Take L.B.I. and slide at least half way over the centrifugal advance mechanism, align the L.B.I. into the opening on light device (see illustration). Let L.B.I. fall over the centrifugal advance mechanism and lay on base of distributor.

8. Position light device into place previously occupied by contact set and replace and tighten hold down screws firmly.
9. Using a good rotor, position it into its proper place, insert two screws and flat washers provided in package (6/32 x 3/4), lift L.B.I. up and align screw holes to rotor hold down screws.
