TO: ALL PASSENGER CAR MANUFACTURERS
ALL LIGHT-DUTY/MEDIUM-DUTY VEHICLE MANUFACTURERS
ALL OTHER INTERESTED PARTIES

SUBJECT: ON-BOARD DIAGNOSTICS II (OBD II) REGULATORY REVIEW

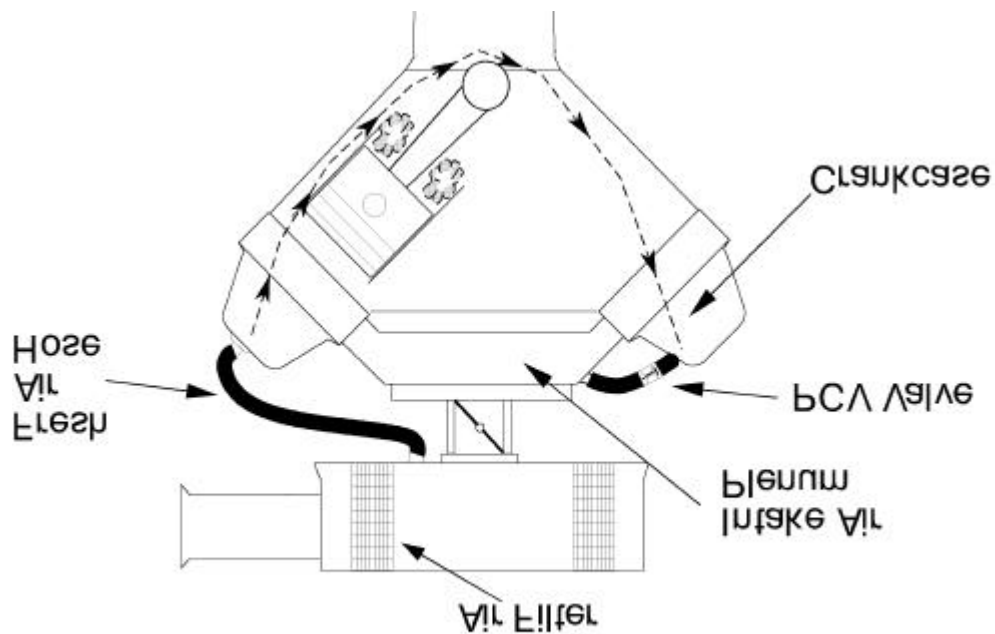
The staff's proposal targets only the failure modes that would most likely result in direct venting of emissions to the atmosphere, namely, disconnection in the system between the crankcase and the intake manifold on the PCV valve side of the system (refer to diagram below). Failure modes of this type are the most likely to cause a substantial increase in emissions (i.e., 1.2 g/mi HC). Other PCV system failure modes include a disconnected fresh air line or a plugged PCV valve but the staff is not recommending that these failure modes require monitoring. This is because disconnection of the fresh air line between the air cleaner and the crankcase may not result in a serious emission problem since most crankcase emissions would still be purged through the PCV valve (an operational PCV valve would cause a negative pressure in the crankcase, resulting in aspirating fresh air through the fresh air line rather than release of crankcase vapors). Further, plugging of the PCV valve will not result in direct venting to the atmosphere unless the fresh air line is also disconnected since pressure build up in the crankcase would likely force vapors through the fresh air line into the air cleaner which would then be inducted into the engine (i.e., this is a closed system). Recognizing the difficulty in detecting a disconnected fresh air line and the limited probability of both malfunctions occurring at the same time, the ARB's proposal would not require detection of this dual component failure.

Typical PCV System

Accordingly, the regulation would require only the detection of a disconnection in the system between either the crankcase and the PCV valve (crankcase vapors would escape directly through the opening in the crankcase system), or between the PCV valve and the intake manifold (crankcase vapors would exit through the PCV valve outlet). In terms of effectively monitoring for such occurrences, the latter failure mode will result in a significant intake air leak that should be identifiable with the existing monitoring strategies for the idle air control system or the fuel system. The staff's proposal would not require the stored fault code to specifically identify the disconnection, provided service information generated by the manufacturer directs technicians to examine the connection as a possible cause of the fault. On the other hand, a disconnection in the system between the crankcase and the PCV valve would be significantly more difficult to detect with existing monitors, and may require added hardware to verify integrity (e.g., a pressure switch to ensure flow between the crankcase and the PCV valve). However, in order to facilitate compliance, the staff's proposal would exempt manufacturers from detecting disconnection between the crankcase and the PCV valve if the PCV valve is fastened securely and directly to the crankcase or valve cover (e.g., a threaded connection). This is because such disconnections often occur during service operations wherein technicians will likely remove the PCV valve and hose assembly together if the valve is easily removed from the crankcase (normally through a grommet located in a valve cover). If the technician finds disconnection of the PCV hose from the valve itself much easier because the PCV valve is securely fastened, then the most likely event is a hose disconnection rather than a valve disconnection. Failure to reinstall a hose, however, can be readily detected with existing monitoring strategies whereas failure to reinstall the PCV valve may not be as easily detected. Therefore, slip-on PCV connections via grommets, or other quick release designs would not be exempted.
