Evaluation of the Potential Impact of Emissions of HFC-134a From Non Professional Servicing of Motor Vehicle Air Conditioning Systems

Provisional Final report

ANNEXES

June 2008

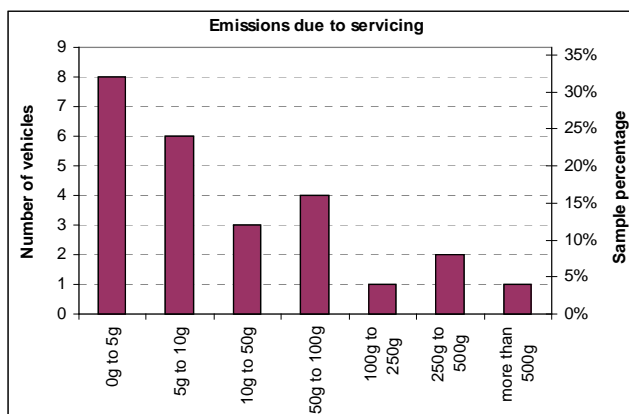
Figure A.1: Number of vehicles as a function of emission range due to servicing (sample 1).

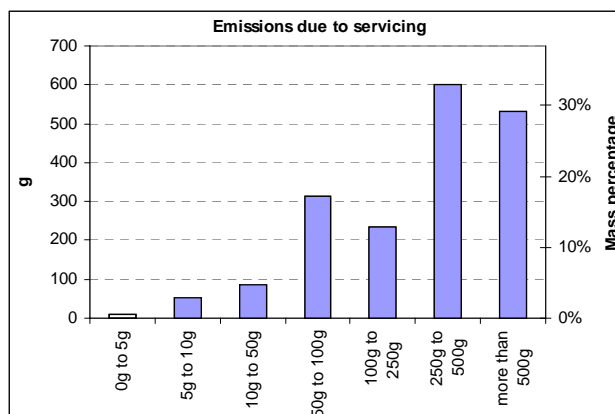
Figure A.2: Mass emission as a function of emission range due to servicing (sample 1).

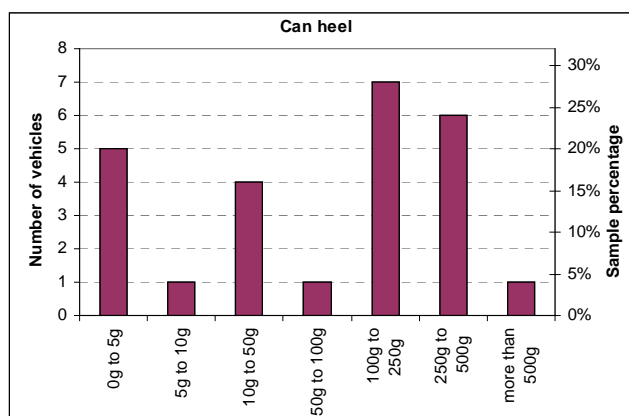
Figure A.3: Number of vehicles as a function of can heel range (sample 1).

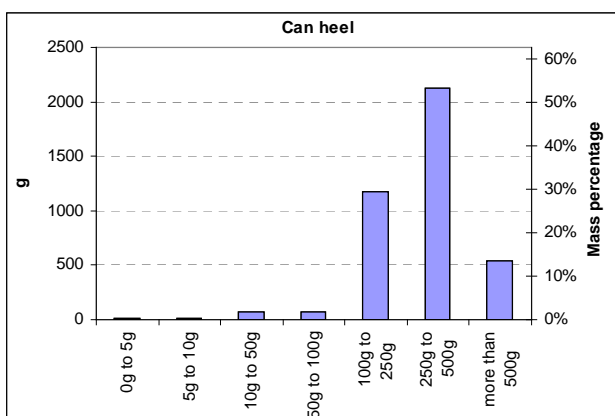
Figure A.4: Mass emission as a function of can heel range (sample 1).

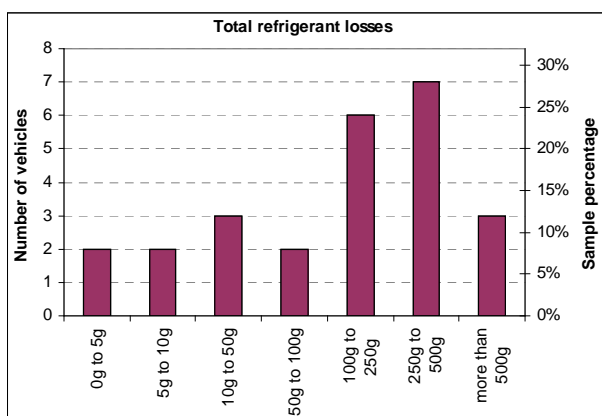
Figure A.5: Number of vehicles as a function of total refrigerant emissions (sample 1).

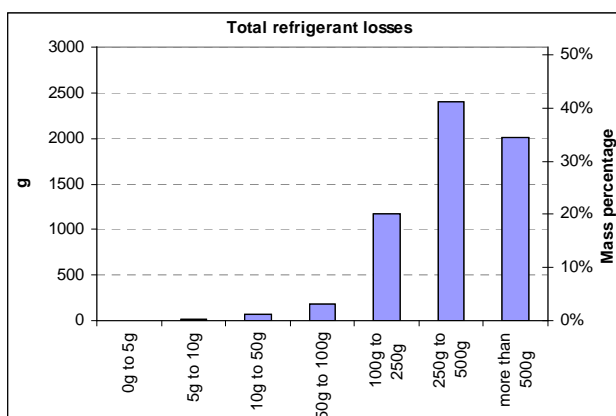
Figure A.6: Mass emission as a function of total refrigerant emissions (sample 1).

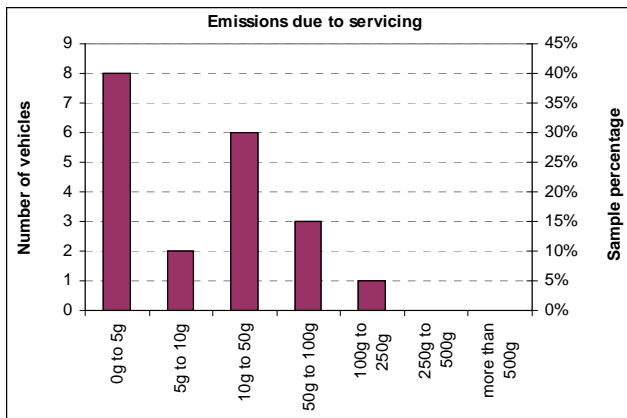
Figure A.7: Number of vehicles as a function of emission range due to servicing (sample 2).

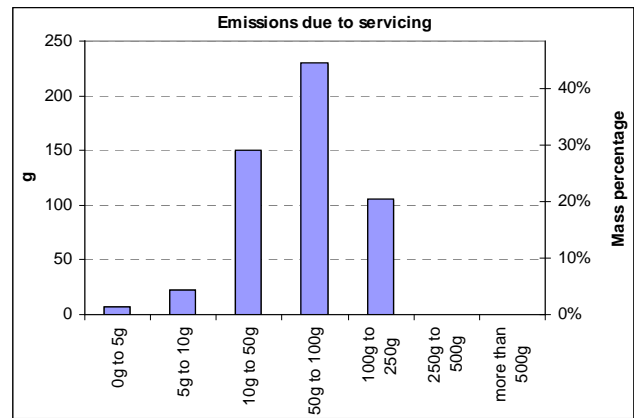
Figure A.8: Mass emission as a function of emission range due to servicing (sample 2).

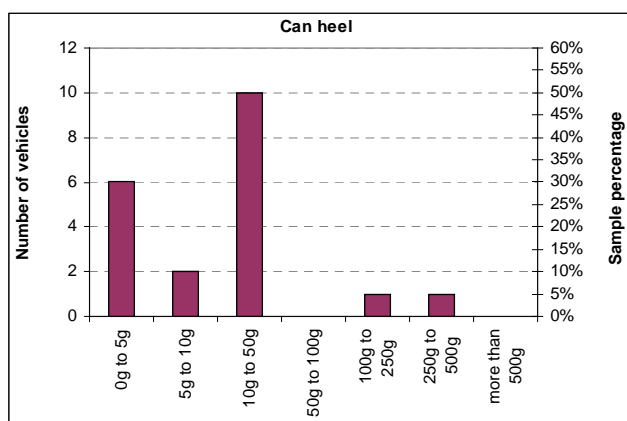
Figure A.9: Number of vehicles as a function of can heel range (sample 2).

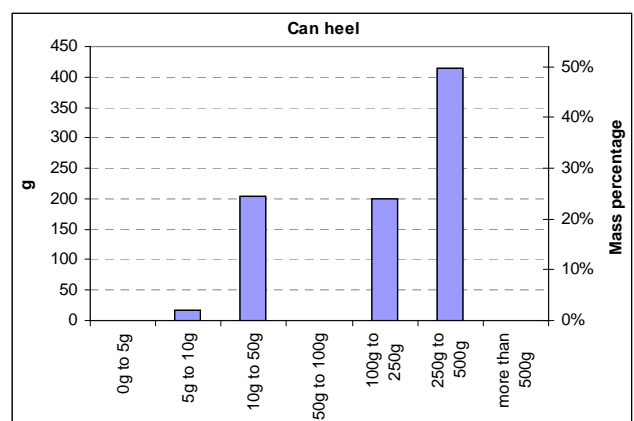
Figure A.10: Mass emission as a function of can heel range (sample 2).

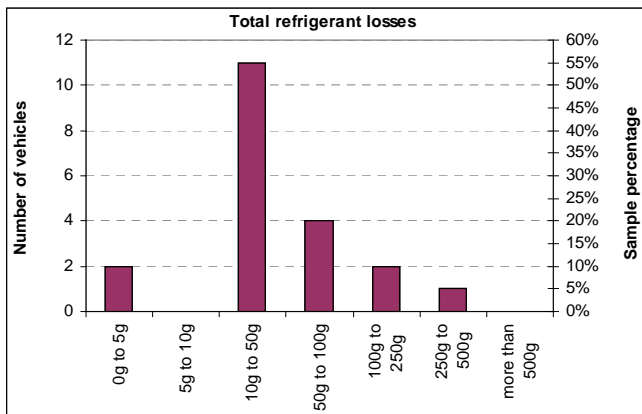
Figure A.11: Number of vehicles as a function of total refrigerant emissions (sample 2).

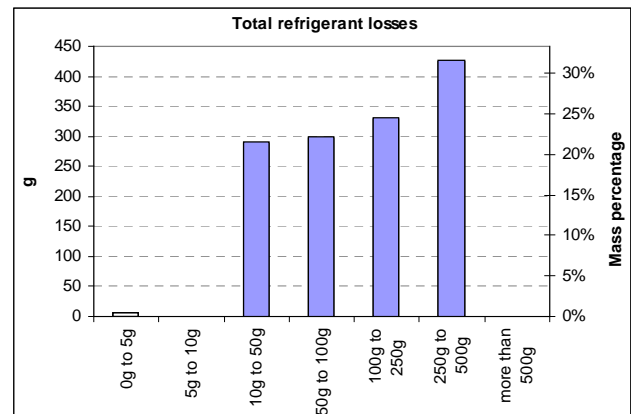
Figure A.12: Mass emission as a function of total refrigerant emissions (sample 2).
