EXECUTIVE ORDER D-89  
Relating to Exemptions under Section 27156  
of the Vehicle Code

ROTO-MASTER, INC.  
"ROTO-MASTER TURBOCHARGER KIT"

Staff Report

Evaluation of the Roto-Master, Inc.  
Turbocharger System in Accordance with  
Section 2222, Title 13 of the California Administrative Code

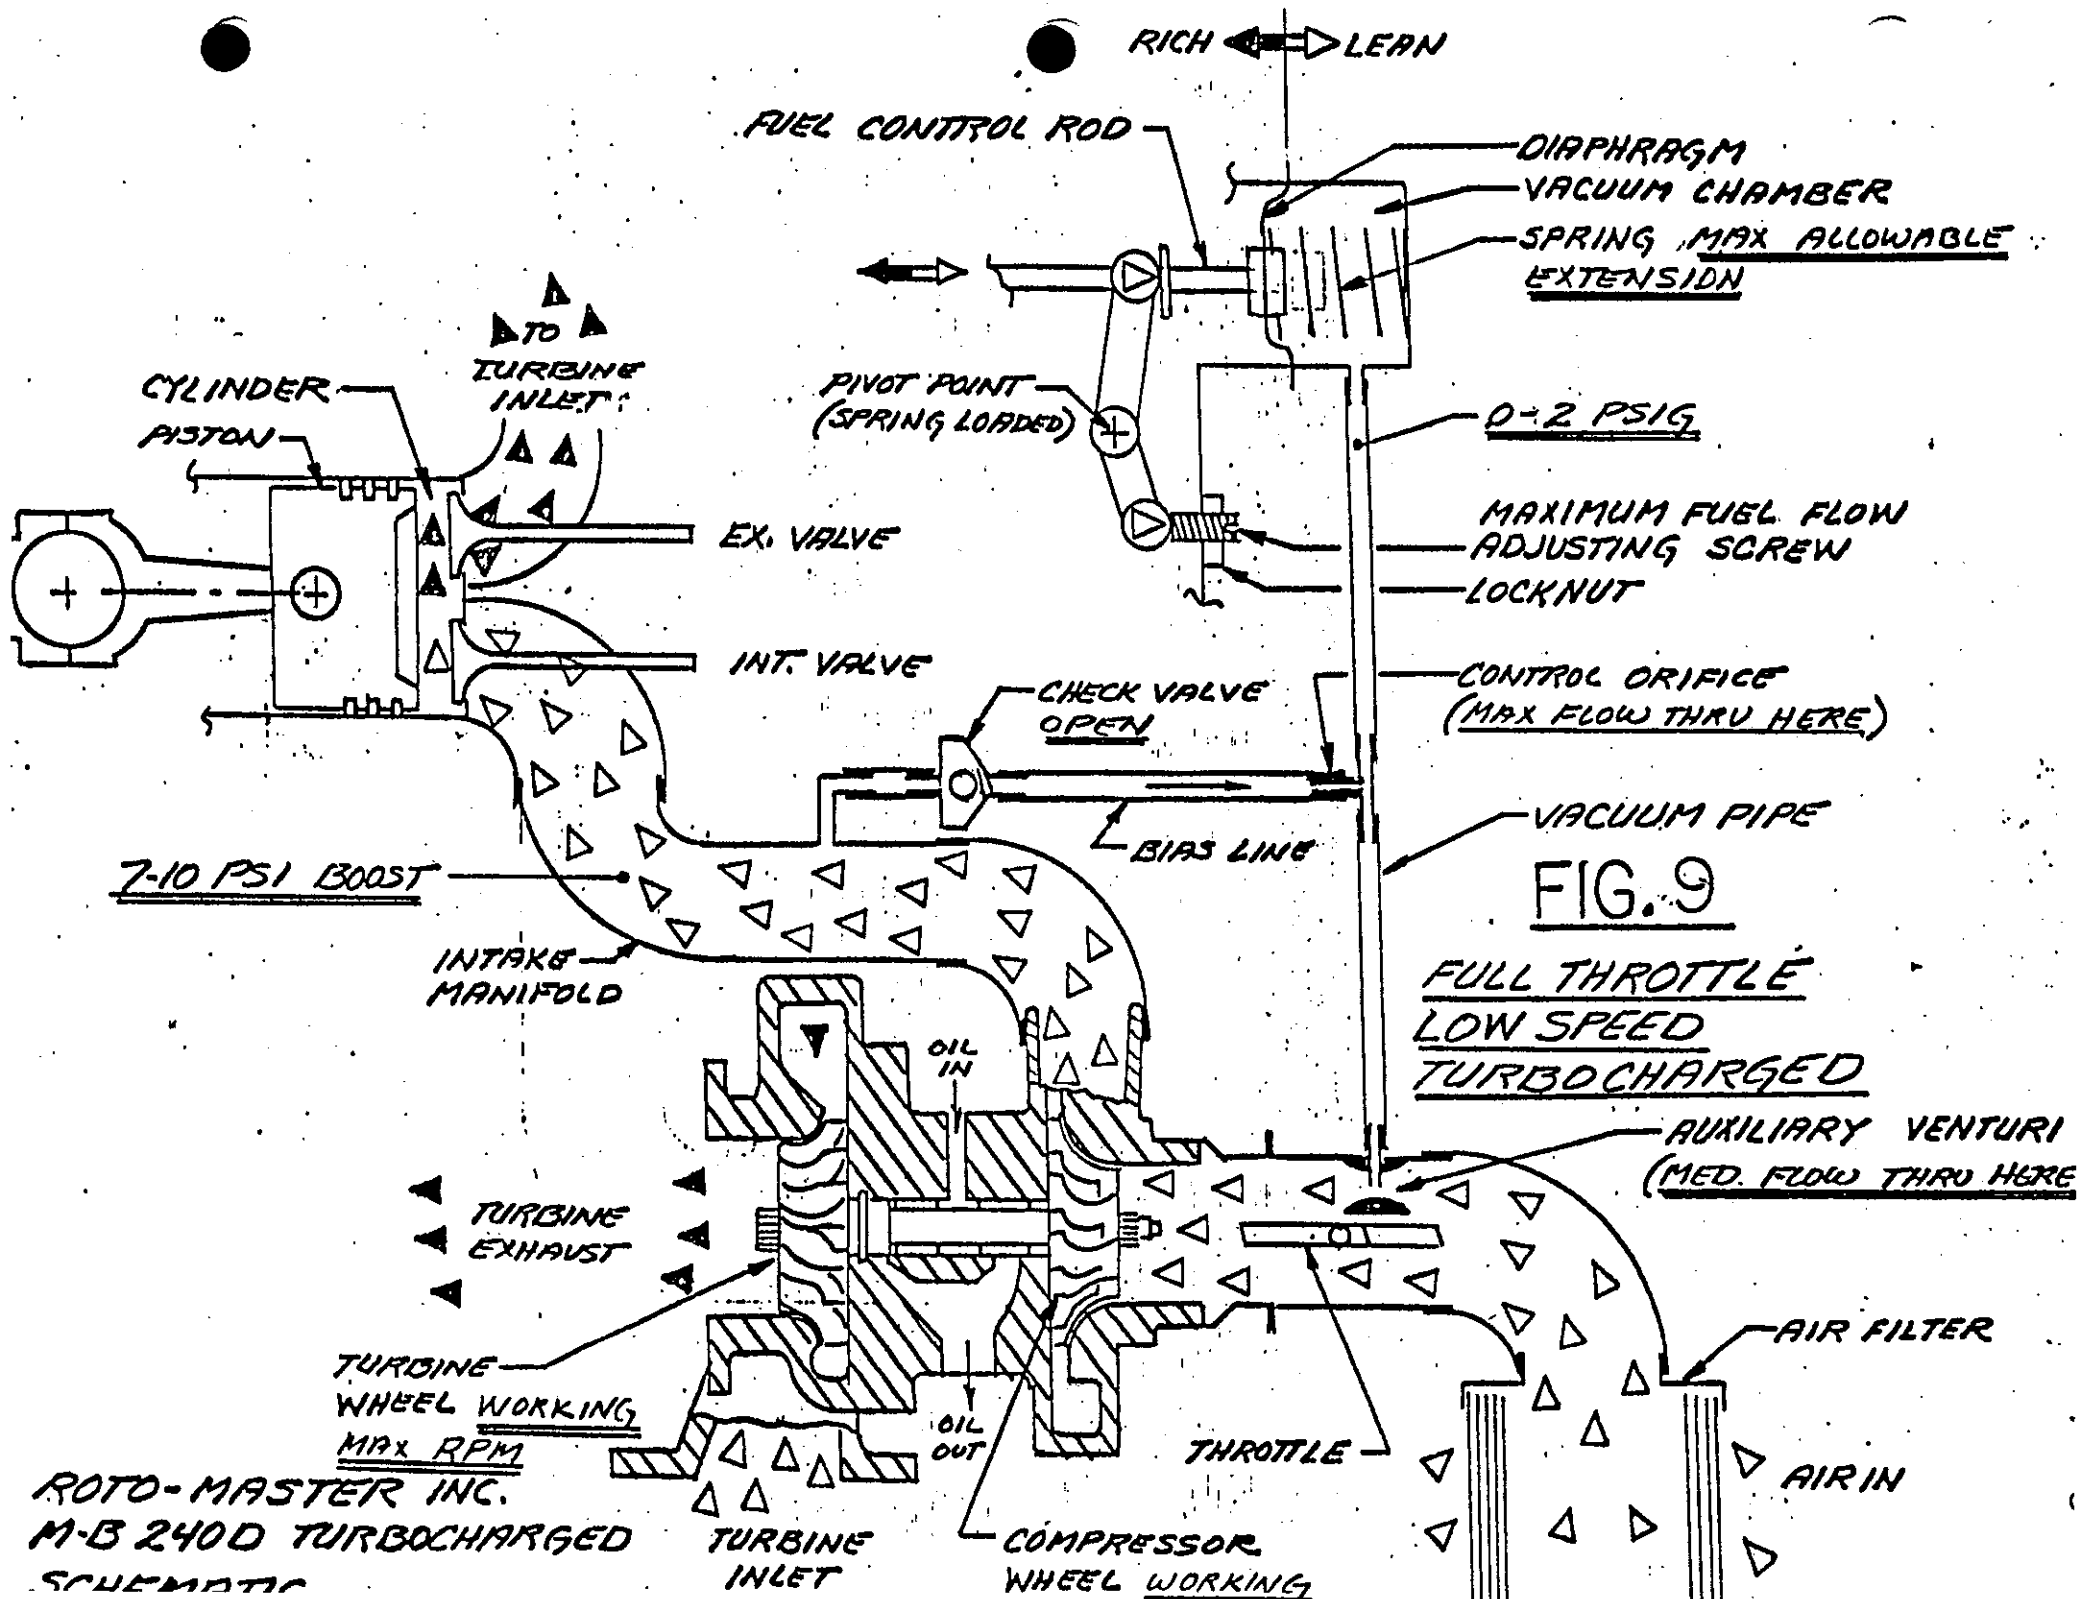
When the throttle is opened fully at medium or low engine speed (Figure 9), the pressure in the intake manifold is much higher than the signal from the auxiliary venturi and will flow through the bias line and control orifice to overcome the vacuum from the auxiliary venturi and cause the pump to deliver maximum fuel.

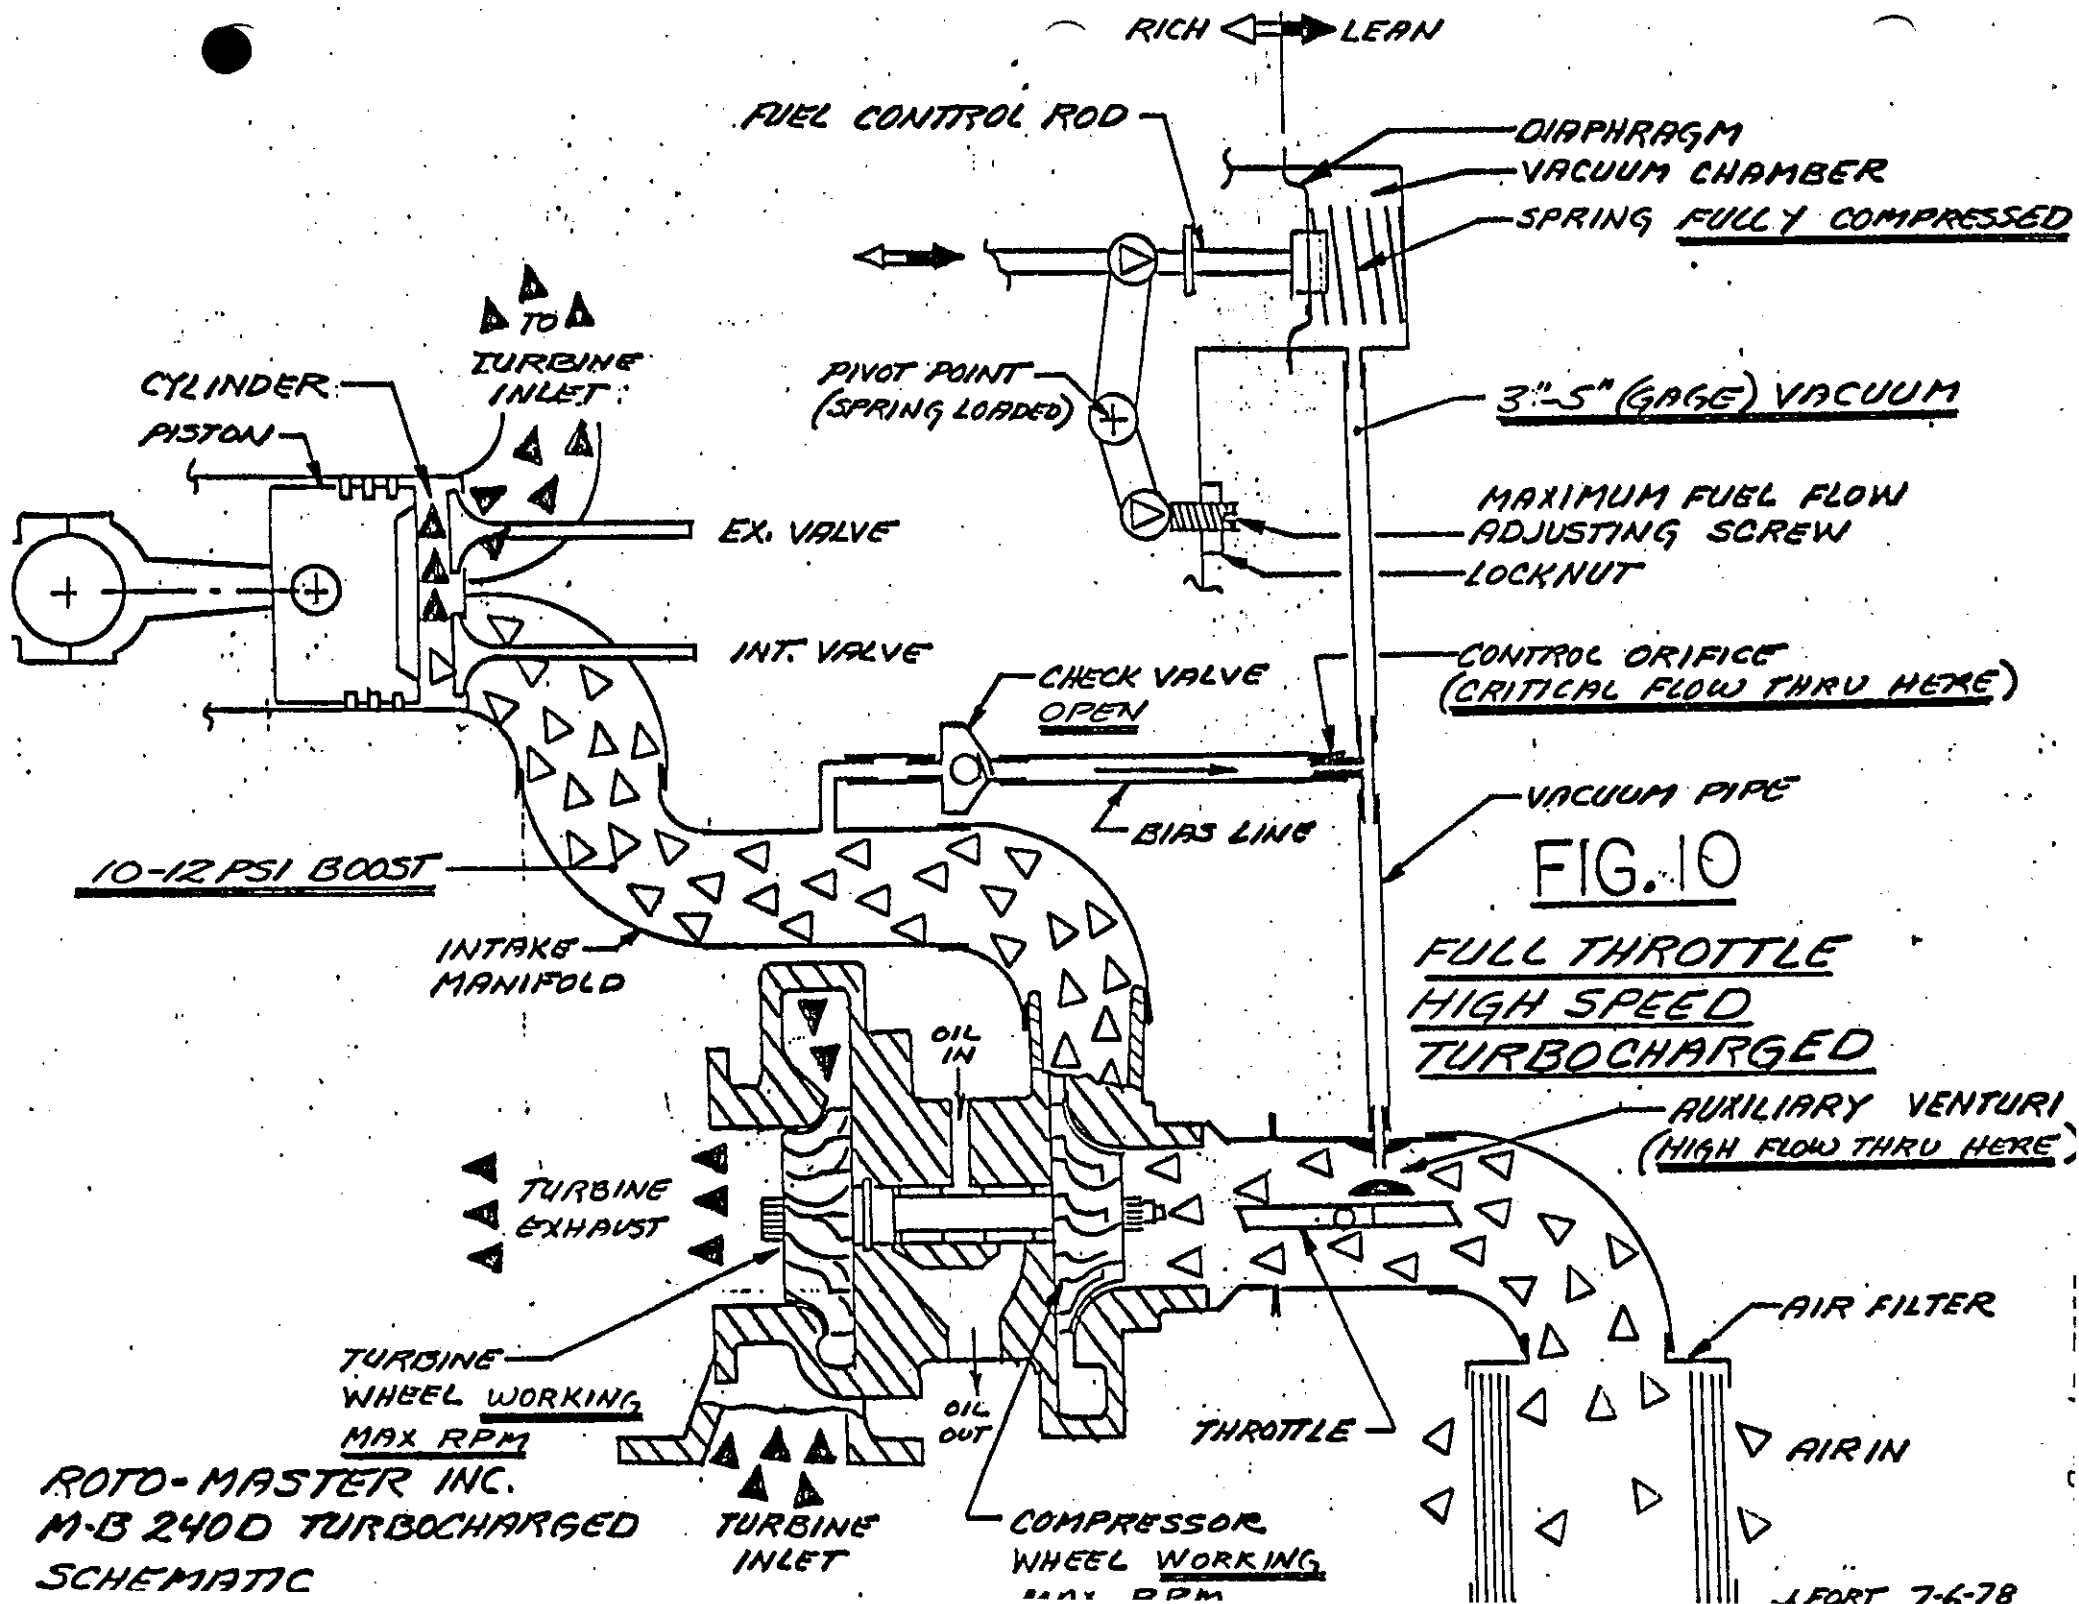
As engine speed increases, the velocity through the auxiliary venturi will increase and the flow through the control orifice will become critical. When this happens, the pressure signal through the bias line will no longer overcome the vacuum signal and the pump will prevent the engine from overspeeding (Figure 10).
